City of Hogansville  
**City Council**  
Work Session Meeting Agenda  
**Monday, April 15, 2024 – 6:00 pm**

**Re: Building Exterior Consulting Services  
Leakage Evaluation Report  
Royal Theatre  
400 East Main St  
Hogansville, GA 30230  
(W&A- 24-00191)**

**Leakage Evaluation Report  
Royal Theatre  
400 East Main St  
Hogansville, GA 30230  
(W&A- 24-00191)**

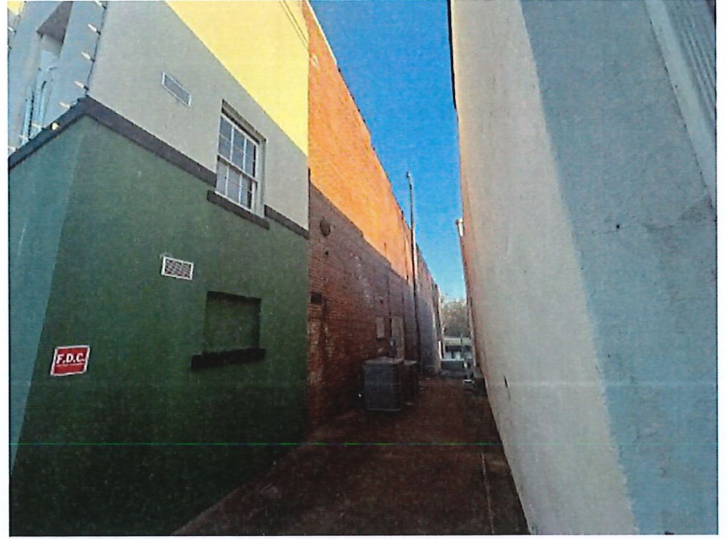
01

**Photo 1** shows the south elevation looking northwest. **Photo 2** shows the east side of the building in the alley. **Photo 3** shows the north elevation, looking southwest. **Photo 4** shows the south elevation, looking northeast. **Photo 5** shows the west elevation, looking northeast. **Photo 6** shows the north elevation, looking southeast. Brick is exposed on a majority of the east and west elevations with all brick on the north elevation of the building.

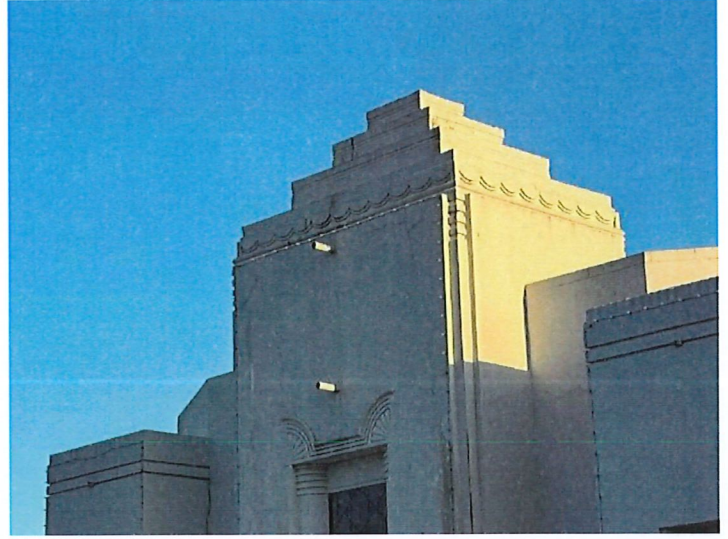
07

**Photo 7** shows an overview of the top hat located on the south elevation of the building and rising above the front entrance. The exposed stucco cladding and cast stone elements exhibit significant cracking on each elevation of the stucco clad walls. The most severe deterioration occurs on the south elevation of the building. Leakage has been reported below the top hat occurring in the original projector room (**Photos 10-11**), reference **Attachment "A"**. Water is penetrating cracks in the attic slab. **Photos 12-14** show the top hat structure within the confines of the attic. A combination of

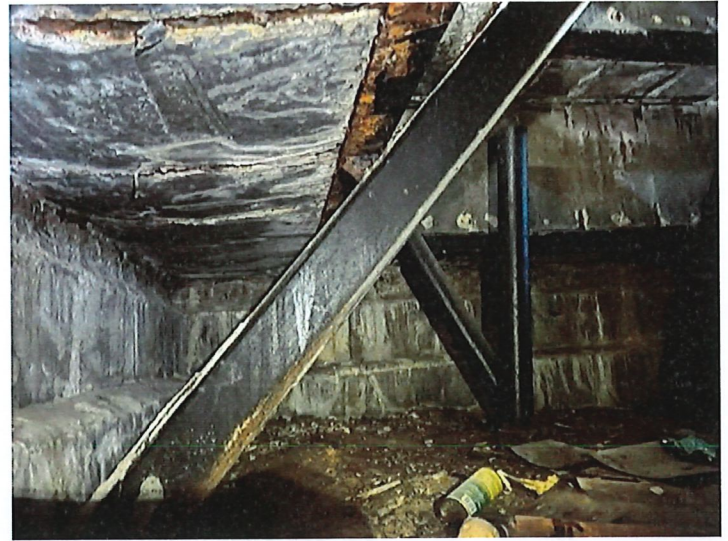
13

structural steel and concrete was observed. There were pronounced cracks in the concrete walls/lids with separation at cast cold joints. There were heavy concentrations of calcium carbonate build-up on the interior walls. The result of prolonged water penetration. Water penetrating the attic enters the projector room through cracks in the slab. Water contracting the floor of the project room has penetrated the slab and resulted in water damage to new interior GWB finishes (**Photo 15**). **Photos 16-17** show the interstitial space above the lobby ceiling and below the projector room floor.

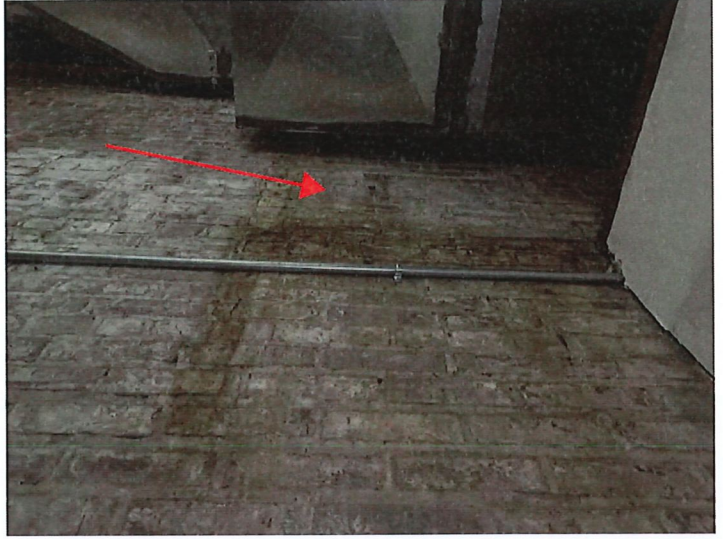
19

**Photo 18** shows the stage. Principle Construction reported leakage occurring along the east wall below the steel truss seen in **Photo 19**, reference **Attachment "A"**. It was reported water migrates down the interior face of the masonry, seen on the wall below the duct work (**Photo 20**). Water collects on the small ledge located along the stairs leading to the basement (**Photo 21**). Water collects on the basement floor, migrating out from behind the new GWB finishes. The leak occurs near/below the east conductor head/downspout (**Photo 22**). Water testing revealed leakage through around the scupper or penetration of the mass masonry wall.

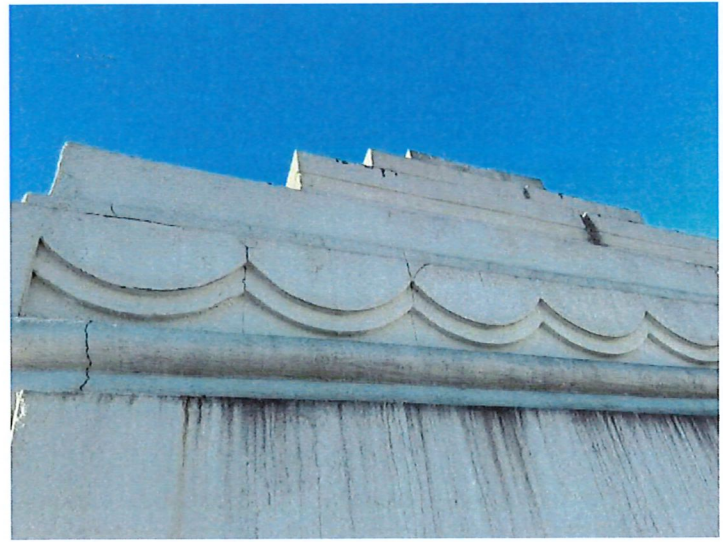
23

- **Photos 23-27** show various cracks and delamination that have occurred in the cast stone elements of the structure. The delamination is likely contributed to water migration into the crack with freeze/thaw cycling, causing the delamination. Delamination of the cast stone elements above the city sidewalk poses concern with life safety. Falling debris can injure pedestrians. Repairs to the cast stone is needed.

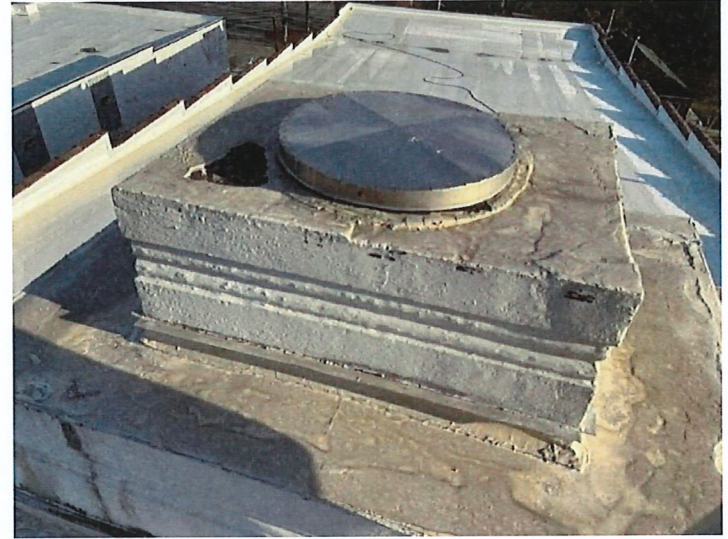
27

- **Photos 27-29** show the corbeled sections of the top hat. The skyward facing surfaces have been coated multiple times with various roof coatings/chemistries. Coating delamination was observed. At the terminating edges, the stucco is deteriorated/delaminated (**Photos 29-30**) allowing water migration of the stucco cladding.

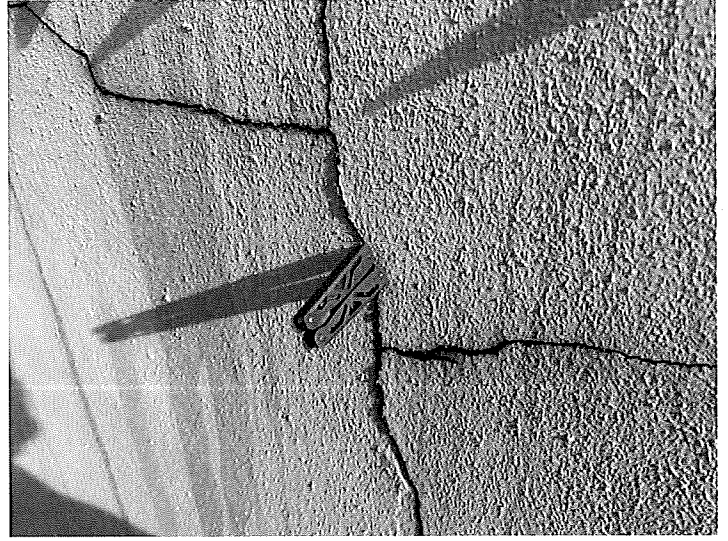
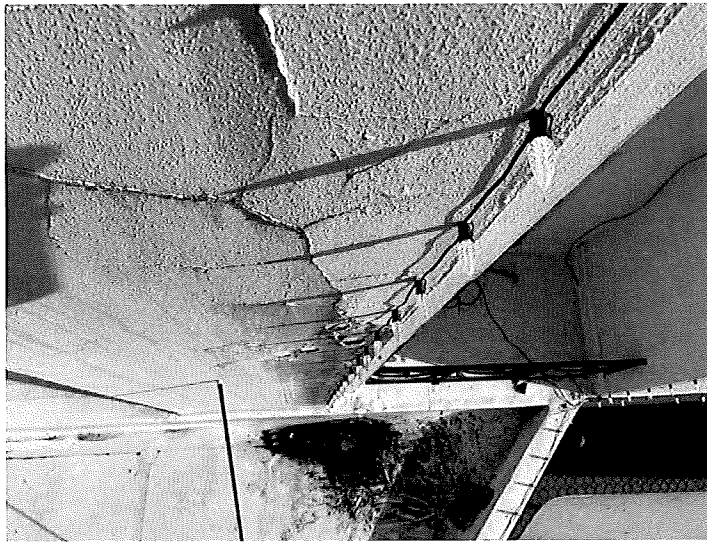
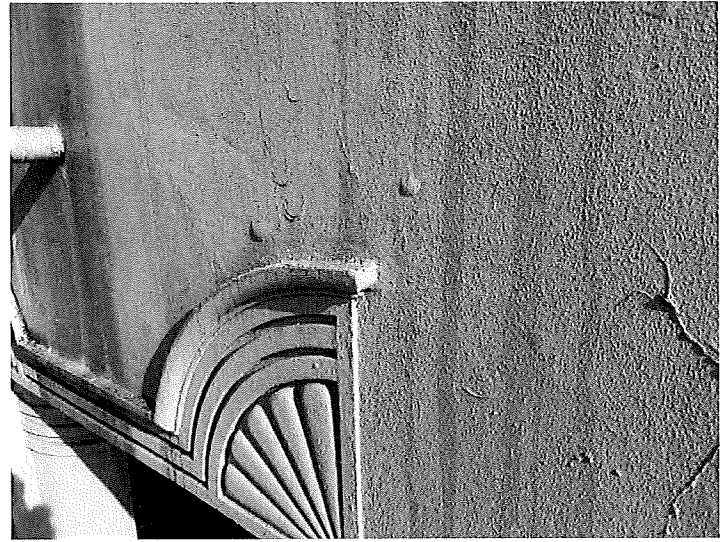
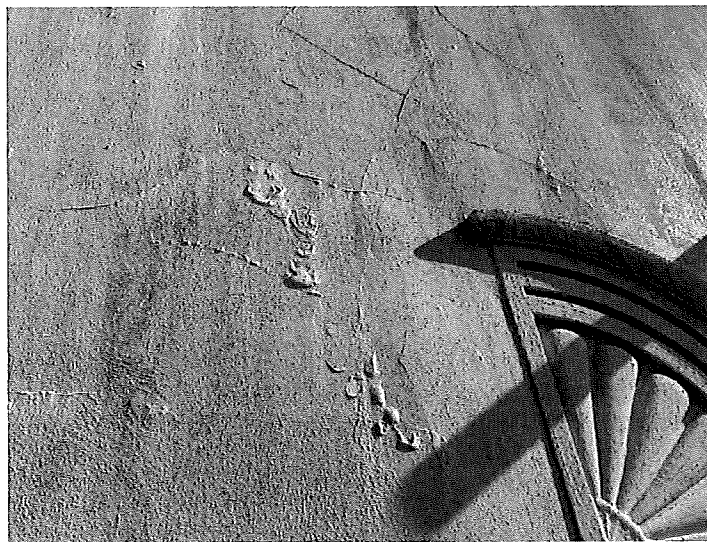
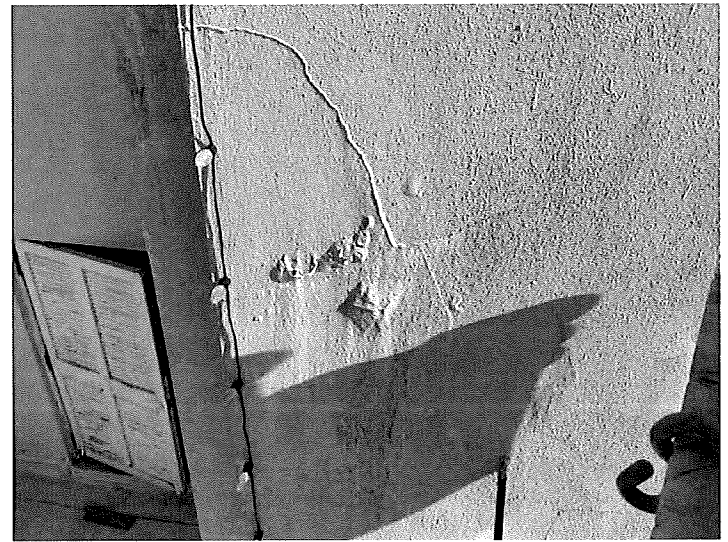
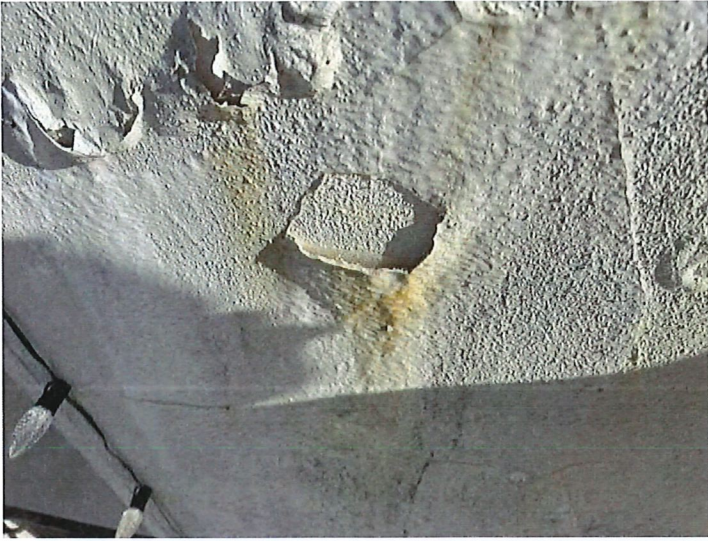
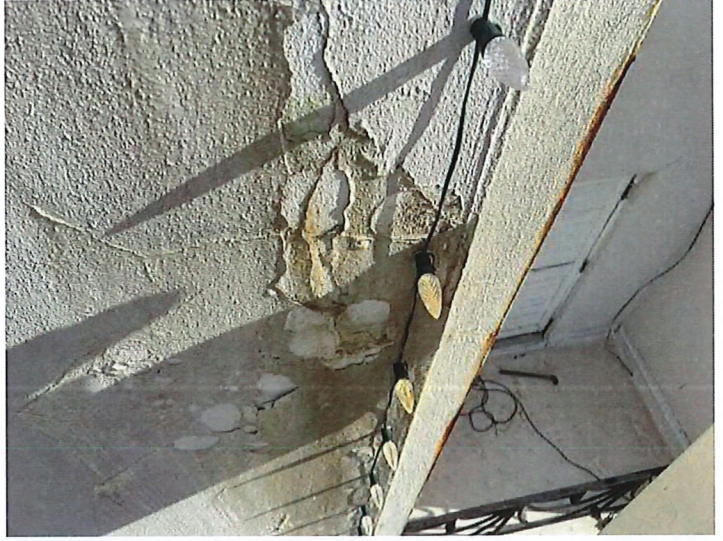
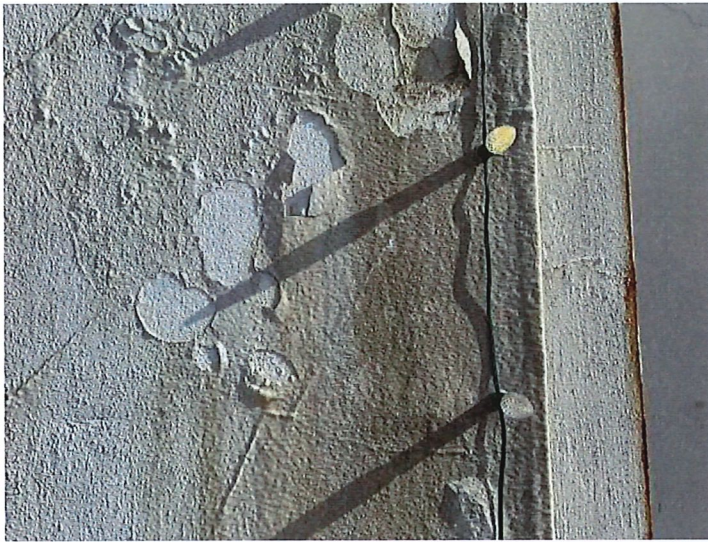
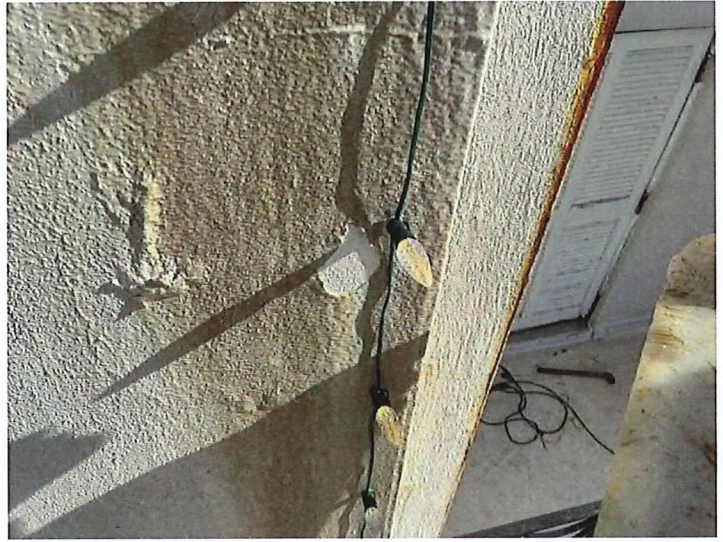
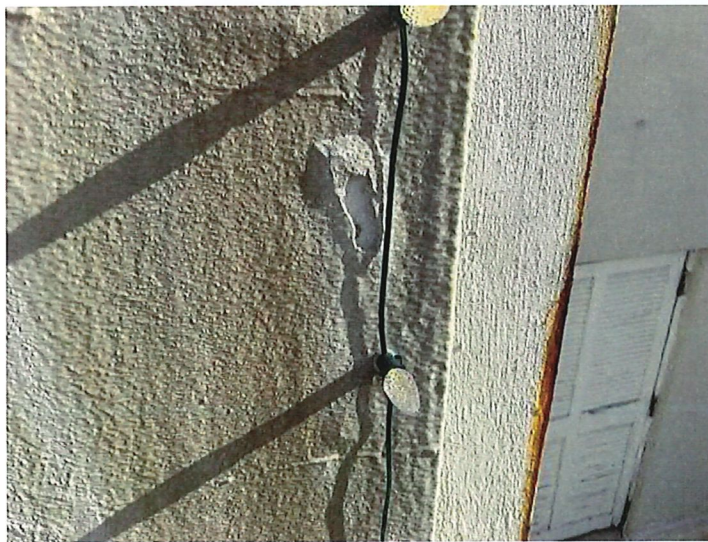
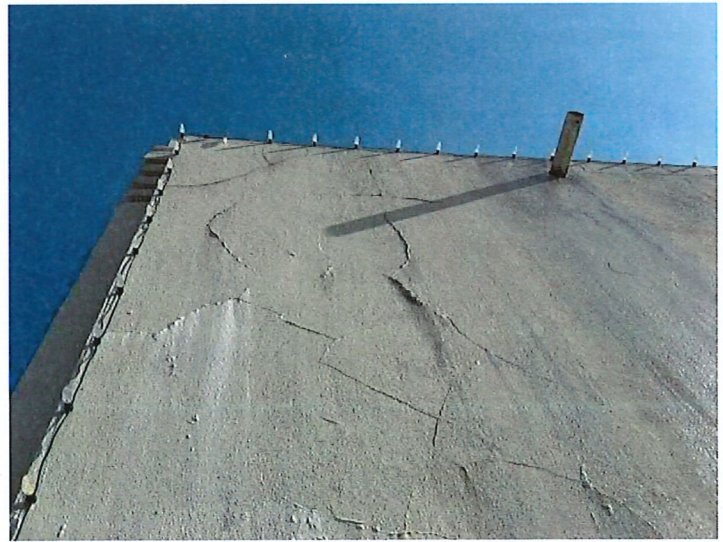
- Water penetrating the cladding through cracks/delamination's has resulted in the development of calcium carbonate on the face of the stucco clad walls (**Photo 31-42**). Water penetration has led to paint/coating delamination. The stucco cladding was sounded and found delaminated from the back-up wall substrate, likely mass masonry. The stucco delamination above the sidewalk poses concern with life safety. Falling debris can injure pedestrians. Removal/replacement of the stucco is recommended.

- In our opinion the full exterior south wall, and partial returns on the east and west walls should be reclad with stucco or other suitable cladding to match that of the existing to maintain the theatres original appearance, along with appropriate roof systems, and incorporated flashings at low slope roof interfaces and at the top hat corbels.
- The walls once repaired should be coated with an elastomeric coating to minimize water penetration.

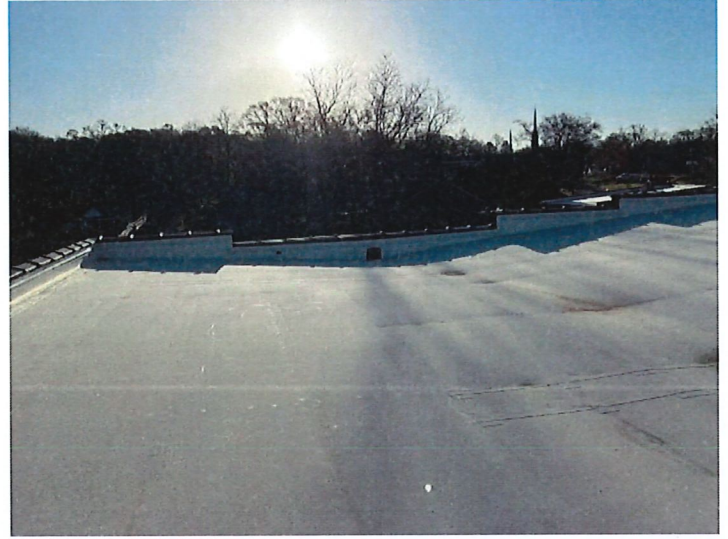
43

**Photos 43-44** show the newer TPO roof system, reportedly installed 5 years prior. The roof slopes primarily from south to north and interfaces a valley and crickets that discharge water from the roof via throughwall scuppers located on the east and west elevation that collect in a conductor head and discharge via a round downspout (**Photo 49**), reference **Attachment "C"**, the original roof plan. Original drawings note 6" downspouts, reference **Attachment "C"**. The current downspouts are 3". It is suspected the conductor heads become overwhelmed in heavy rains. These scuppers are located above the steel truss seen above stage in the theatre. The roof appears visibly in good condition.

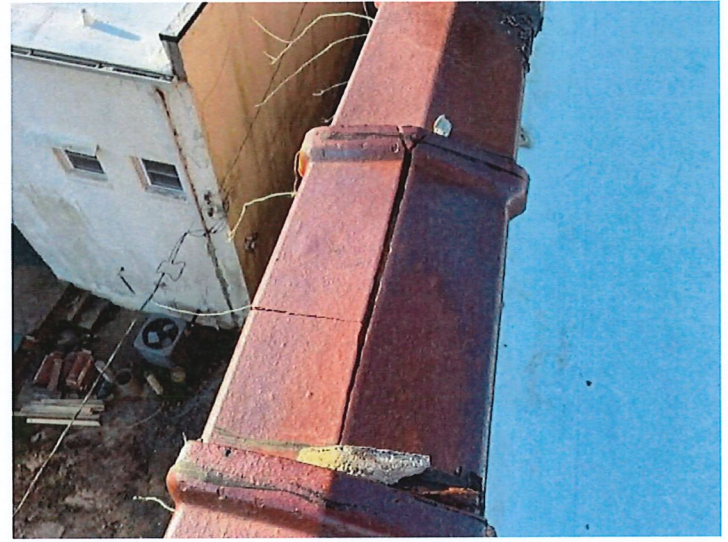
45

The roof parapets are capped with terra cotta copings (**Photo 45**). The terra cotta coping in general is in fair condition with only several broken units. **Photos 46-48** show one of the broken units. It appears the break is recent. The loose pieces were removed to eliminate an overhead falling hazard. The mortar filled joints between the units were in poor condition and can permit water penetration. Water penetrating the terra cotta coping can allow water leakage into the mass masonry structure. The broken sections should be replaced. The existing mortar filled joints should be ground back and the joints sealed with an approved sealant that will bond to the glaze, improving watertightness.

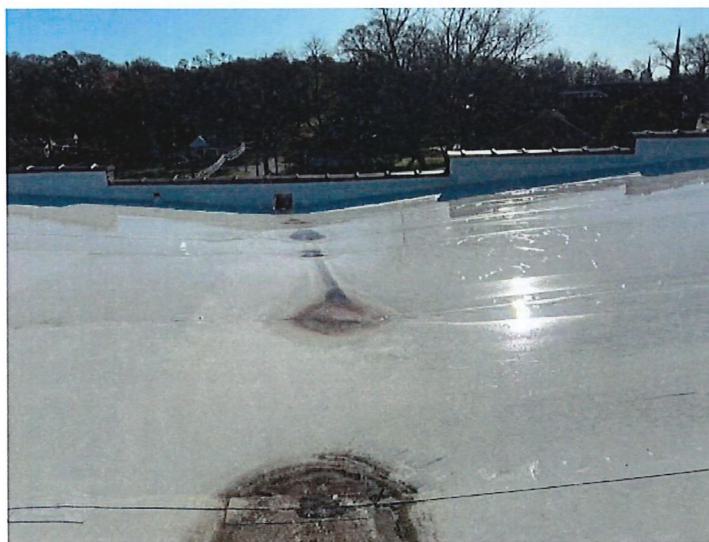
50

**Photo 50** shows the spray bar placed on the roof upslope of the valley, spraying water into the air then cascading back onto the roof. **Photo 51** shows the sheet flow of water on the roof surface, directed from the valley/crickets to the east scupper. During the test, water was observed leaking from joints in the conductor head and downspout (**Photos 52-54**). During the 2-hour test, no leakage was witnessed below the roof on the interior.

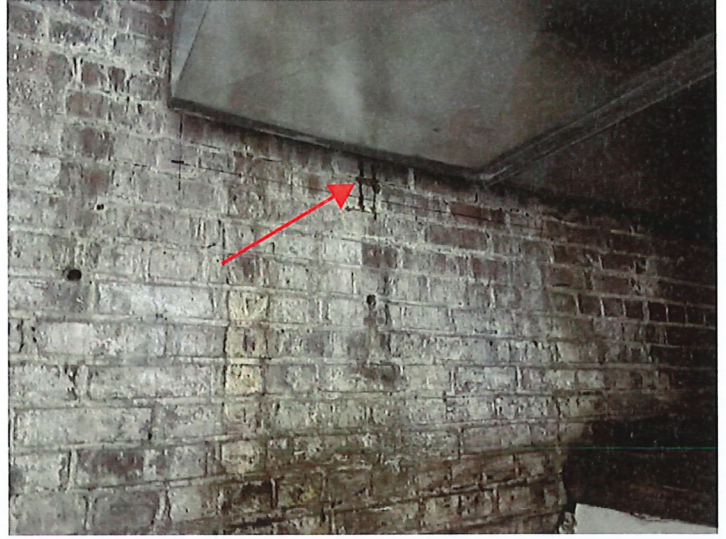
55

**Photo 55** shows the spray bar placed on the roof upslope of the valley, at the north end of the roof. Water was sprayed into the air then cascading back onto the roof. After approximately 1 hour testing, water was seen leaking below the steel truss and running down the wall behind the duct work (**Photos 56-58**). The test was stopped. The leak is suspected to water penetrating the scupper sleeve penetrating the masonry parapet and or from saturation of the mass masonry wall below the scupper being wetted by the leaking conductor head.

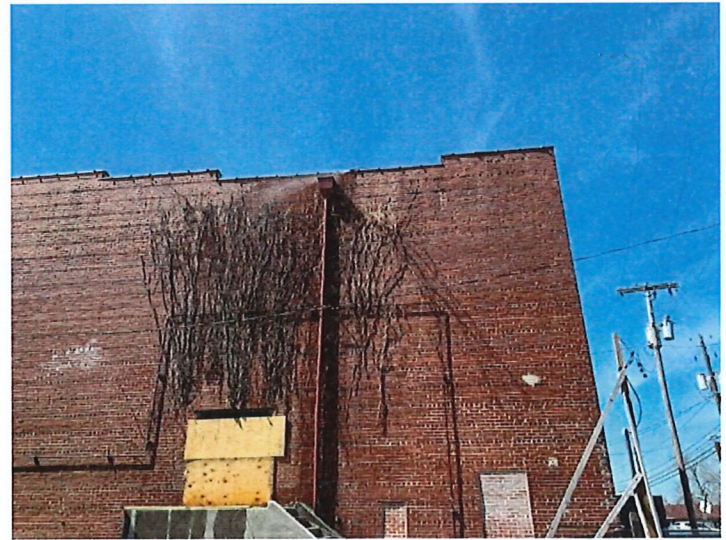
59

After observing the leak. We placed the handheld nozzle atop the terra cotta coping with water spray directed at the conductor head and mass wall (**Photos 59-60**). **Photos 61-62** shows voids in the mortar joints that will permit water penetration of the wall. During this test, there was a significant increase of water penetrating the mass masonry wall (**Photos 63-66**).

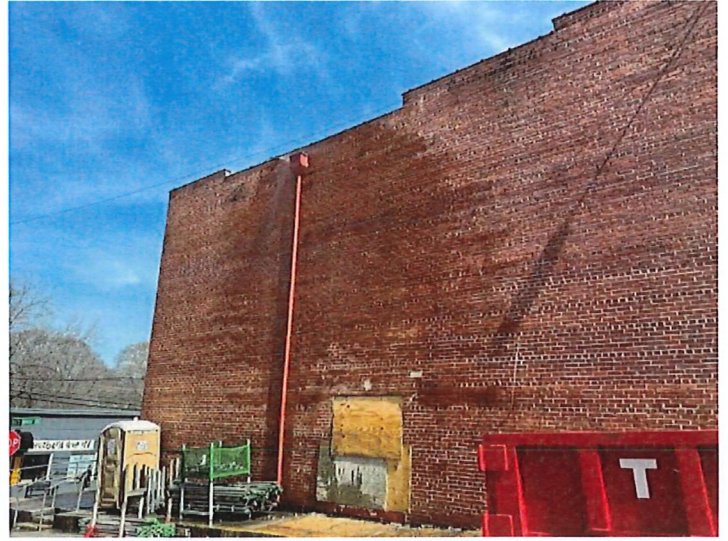
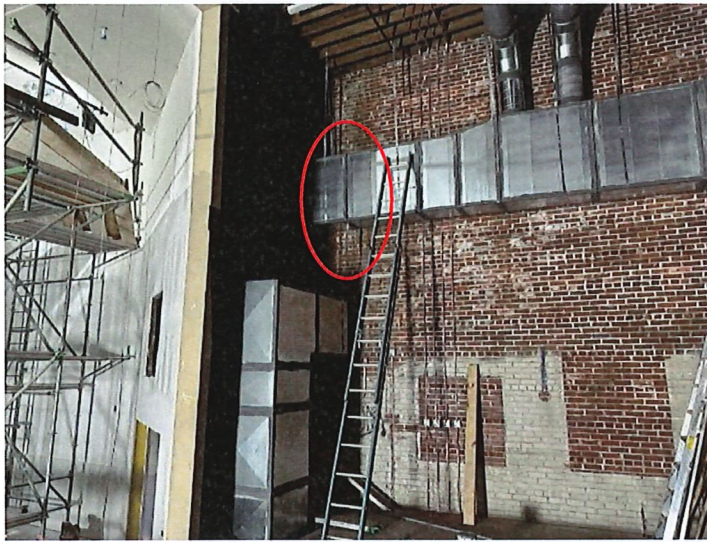
After observing the leak on the east side and with water stains present on the interior wall, west side beneath the scupper. We tested the west wall using the same handheld nozzle placed atop the terra cotta coping with water spray directed at the conductor head and mass wall (**Photos 67-68**). After approximately 1 hour of testing, water was observed penetrating the mass masonry wall (**Photos 69-73**).

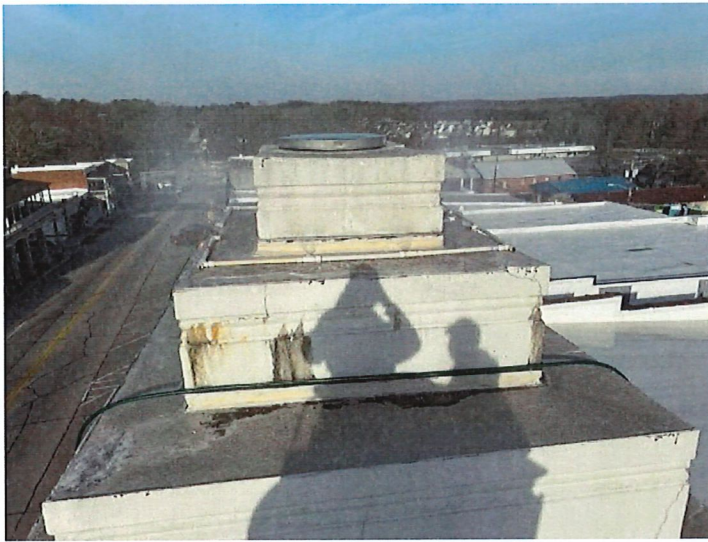
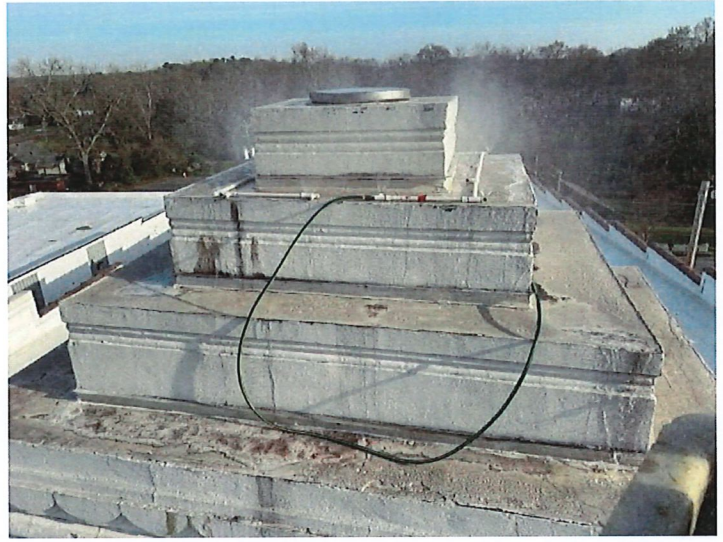
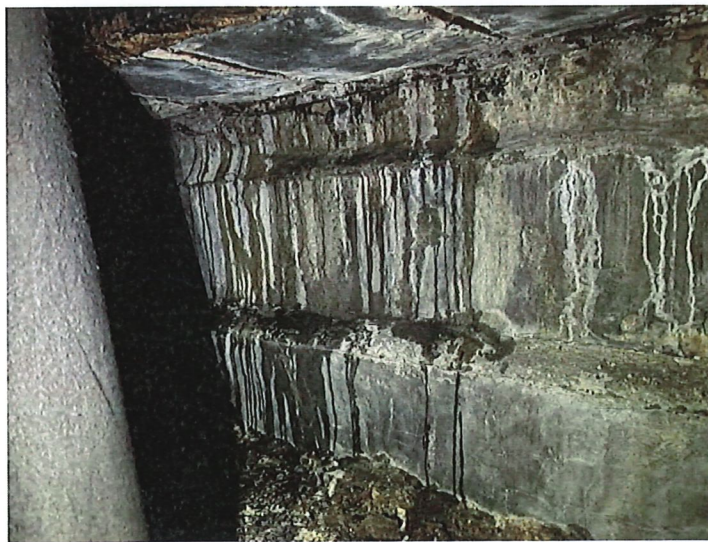
**Photos 74-76** show the spray bar placed on the upper corbel of the top hat with water sprayed into the air then cascading back onto the structure. Within 5 minutes of testing, a significant amount of water was observed penetrating the structure located in the attic above the projection room (**Photos 77-79**). Water collected on the floor of the attic and penetrated cracks in the concrete deck (**Photos 80-81**). Water then collected on the floor of the projection room (**Photo 82**). Water is penetrating the failing stucco and the delamination/cracks in the cast stone elements leaking to the interior through cracks and cold joints in the top hat construction.

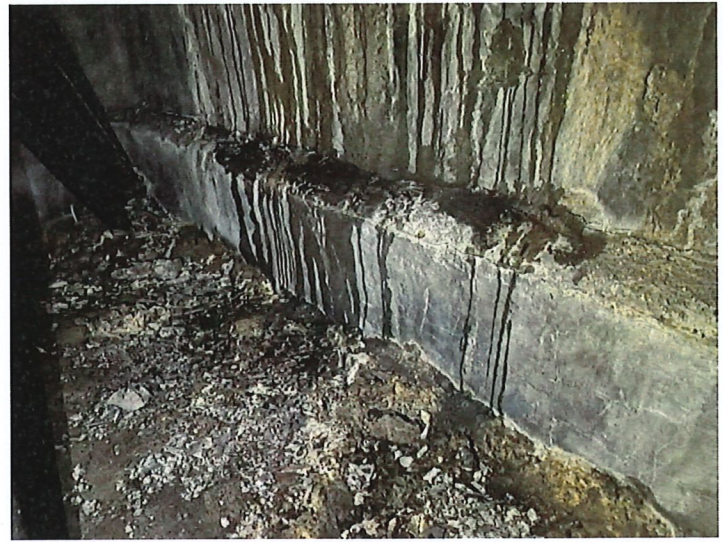
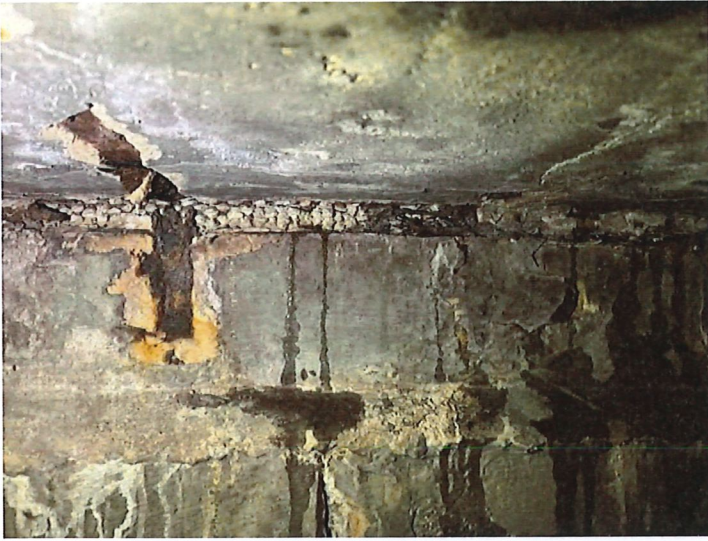
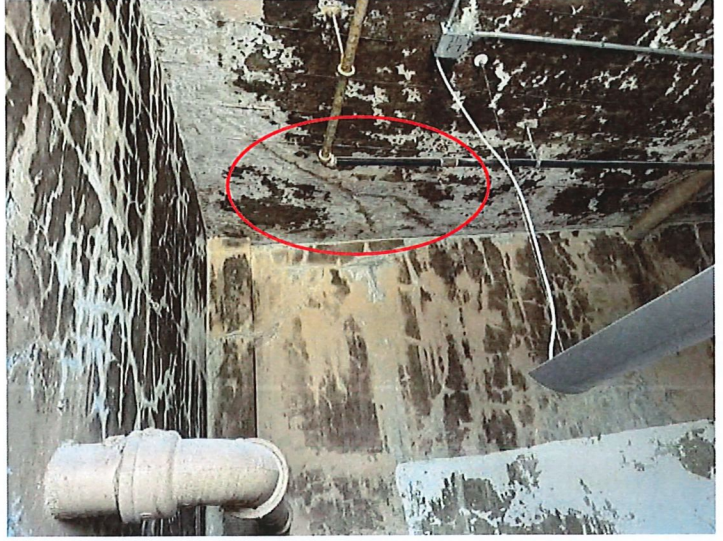
Water leakage below the top hat is related to the physical distress in the exposed exterior elements along with a failing fluid applied roof coating(s) and cast cold joints and/or cracks in the corbeled section of the top hat. To address the top hat and stucco clad walls, we recommend the following:

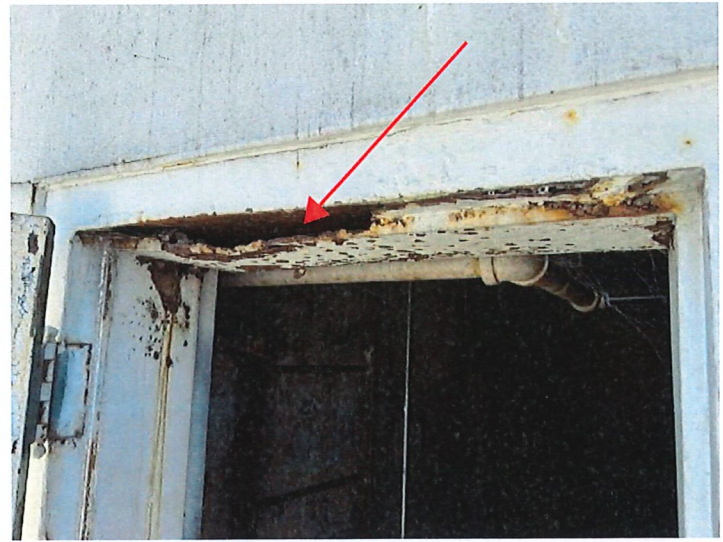
83

The roof is accessed through a small sized steel hollow metal door/frame. The frame is significantly corroded and will permit water penetration through/around the door and cause leakage in the projector room (**Photos 83-85**). The door should be replaced with a new access door that has watertight performance ratings to reduce the risk of leakage.

W&A also recommends replacing the roof access door, as the door is significantly corroded at its' head and sill, and the door does not properly close. Rainwater will penetrate the access door, as it is not weather protected.
