The Hogansville Design Manual

Hogansville, Georgia

**Prepared By
The Jaeger Company
Gainesville, Georgia**

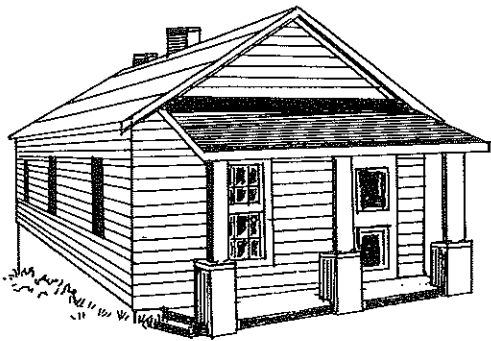
A typical Shotgun in Hogansville.

Shotgun - One of the better-know house types, the shotgun is a linear one-story dwelling, one room in width and two or more rooms in depth. There is no hallway in a shotgun house but rather a consecutive series of passageways, beginning with the front door and continuing through the house to the back door. Most shotguns feature front-gable roofs, although hipped roofs are also seen.

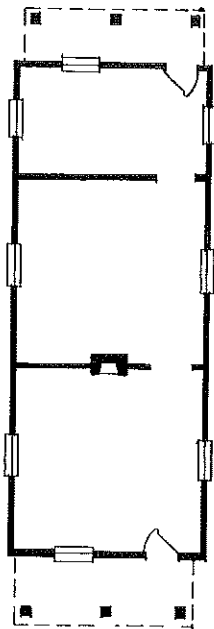
The Shotgun floorplan.

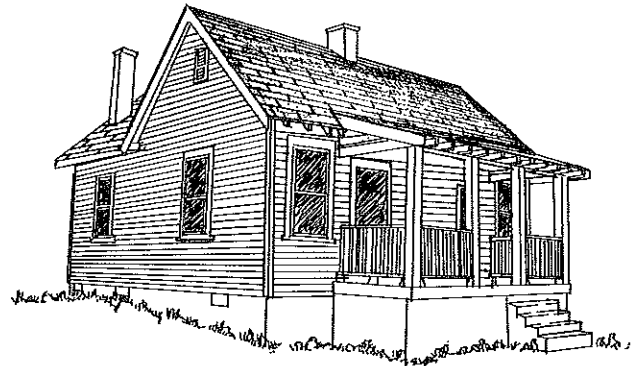
This Saddlebag is a typical Hogansville mill community example.

Saddlebag - The saddlebag is a one-story house with a side-gable roof and consists of a central chimney flanked by two equally-sized rooms, either with an opening into each or one central opening with access to both rooms. These rooms are usually square in shape. Most of the saddlebags in Hogansville were constructed as mill housing. These mill houses have two doors and were built with a one-room ell extension to the rear.

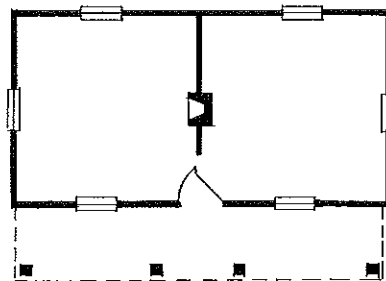
The Saddlebag floorplan.

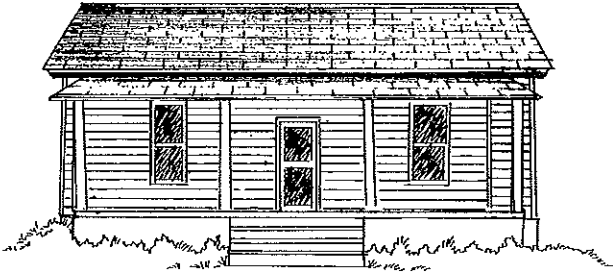
Central Hallway Cottage - Also one-story in height featuring a side-gable roof covering two equally-sized rooms, this type features a centrally-positioned hallway between the rooms and is only one room deep.

A typical Central Hallway Cottage in Hogansville.

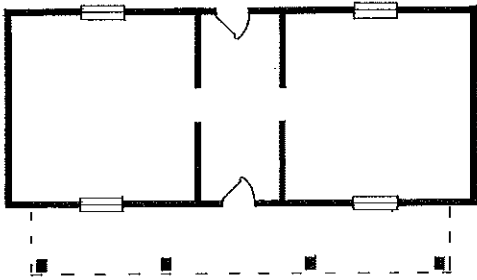
The Central Hallway Cottage floorplan.

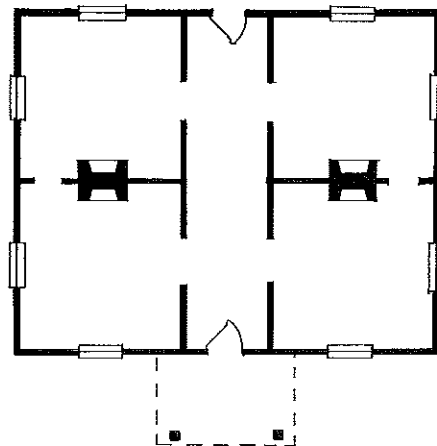
The Georgian Cottage floorplan.

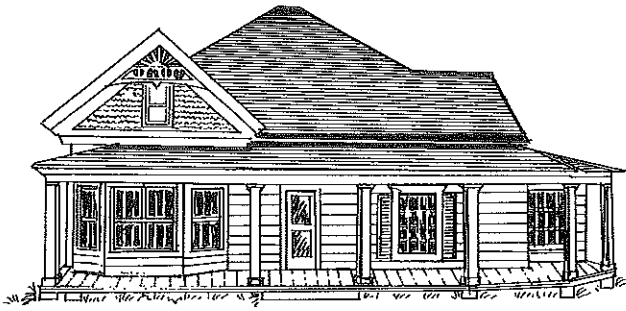
A typical New South Cottage in Hogansville.

New South Cottage - This house type appeared in great numbers following the Civil War and into the early 20th century, hence the name "New South" Cottage. It features a square central main mass with a central hallway plan and usually two gabled projections. A hipped roof is most common.

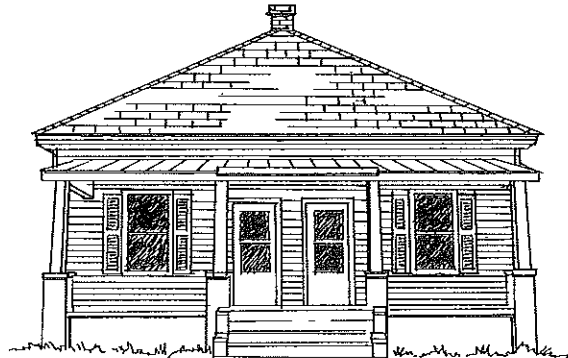
A typical Pyramid Cottage - Duplex in Hogansville.

Pyramid Cottage - Duplex - Square in shape and consisting of four rooms with no hallway, the Pyramid Cottage is distinguished by a steeply-pitched pyramidal roof. The Hogansville variation of this type features two entrances on the front facade, as these dwellings were originally duplexes.

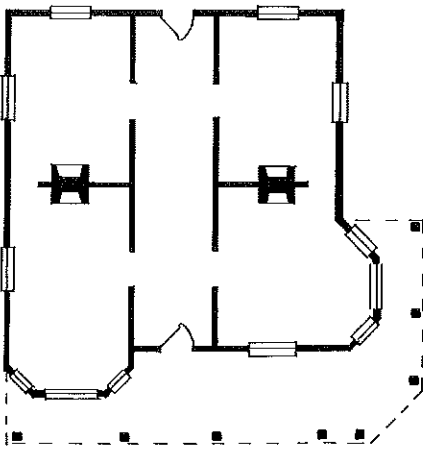
The New South Cottage floorplan.

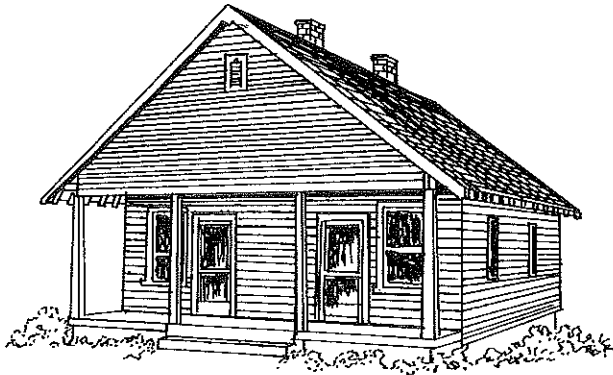
A typical Temple-front Cottage - Duplex in Hogansville.

Temple-front Cottage - Duplex - The name of this house is in reference to its integral or recessed front porch, which results in a temple-like appearance. Most houses of this type are two or three rooms deep and have hall-parlor plans, although central-hallway plans are also seen. Some Hogansville Temple-front Cottages, having been built as duplexes, exhibit two front entrances.

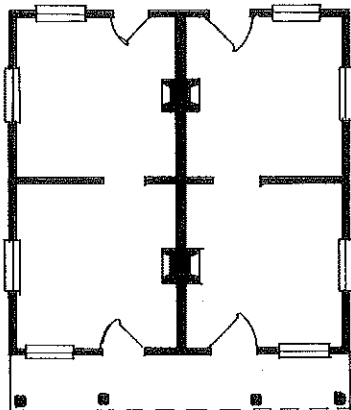
The Temple-front Cottage - Duplex floorplan.

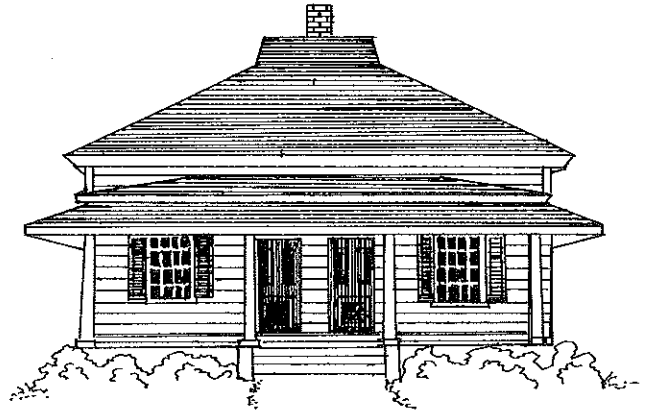
A typical Gable-on-Hip Duplex in Hogansville.

Gable-on-Hip Duplex - This house type is virtually identical to the Pyramid Cottage - Duplex with the exception of the interesting gable-on-hip roof. Several of these houses may be found on Granite Street.

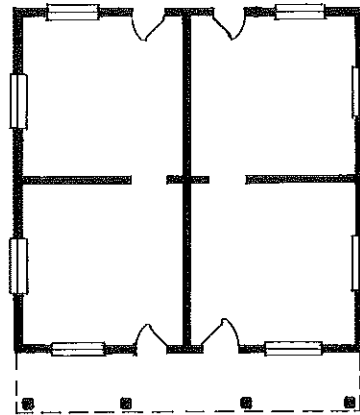
The Gable-on-Hip Duplex floorplan.

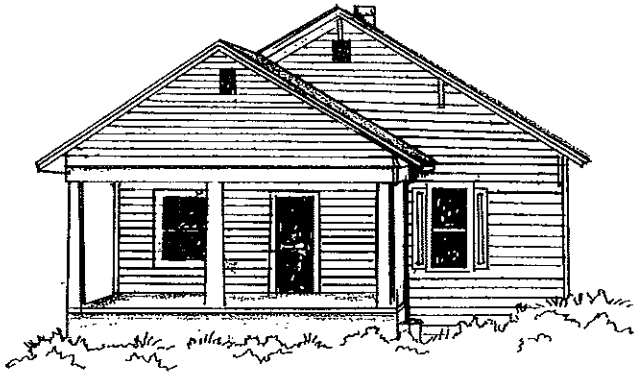
Front-gable Bungalow - Bungalows typically feature irregular or hall-parlor floor plans. The front-gable bungalow is two or more rooms deep, exhibits a low-pitched front gable roof and has either an integral (recessed) or extended gabled entry porch.

A typical Front-gable Bungalow in Hogansville.

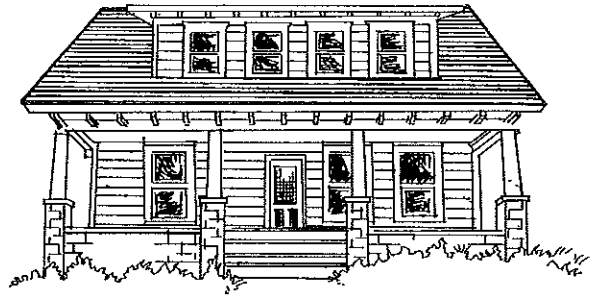
Side-gable Bungalow - Also featuring an irregular floor plan, the side-gable bungalow is two rooms deep, is characterized by a low-pitched side-gable roof and usually exhibits a full-facade integral or extended front porch.

A typical side-gable Bungalow in Hogansville.

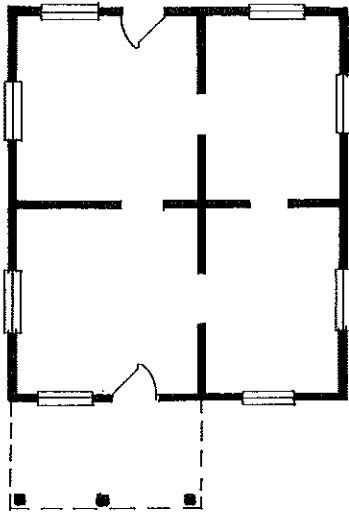
The Front-gable Bungalow floorplan.

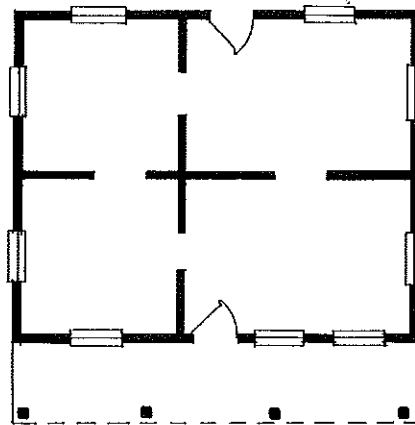
The Side-gable Bungalow floorplan.

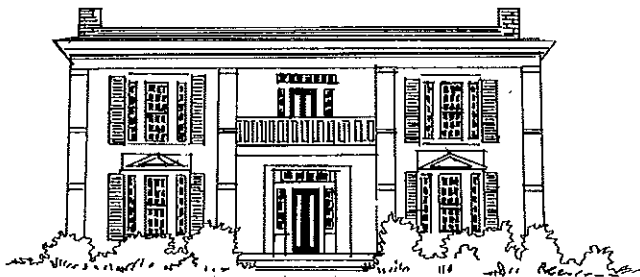
The Phillips-Smith House, Maple Street.

GREEK REVIVAL (1830-1865) — Greek Revival was the dominant architectural style in antebellum Georgia after achieving widespread popularity in the 1840s. It is a style that appears not only on grand mansions but also on the most simple of residences. Emphasis is usually placed on the entrance, which is almost always centrally-positioned.

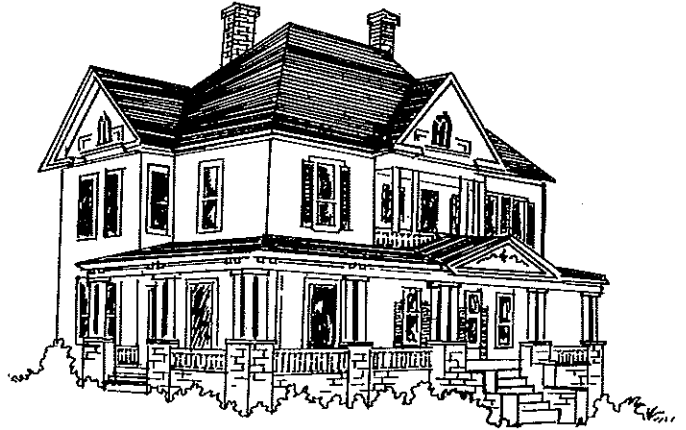
Fair Oaks", East Main Street.

QUEEN ANNE (1880-1900) - The most popular 19th century residential style in Georgia (in terms of the number of houses constructed), the Queen Anne style is characterized by highly irregular "picturesque" facades with a variety of exterior surface materials and detailing. Roofs are often steeply-pitched and feature several projecting gables.

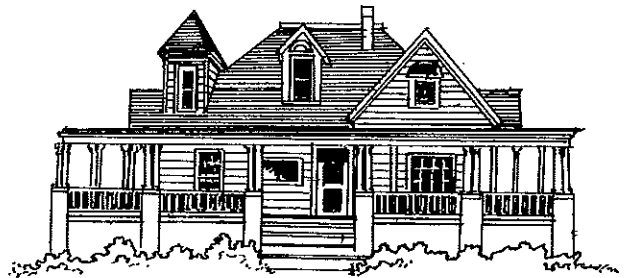
The Davis-DeMarrais House, East Main Street.

FOLK VICTORIAN (1880-1910) - Vernacular house types that exhibit Victorian-era ornamentation are known as Folk Victorian dwellings and are very common in all parts of Georgia. These houses are built on the same floor plans as the house types discussed earlier and feature a limited amount of stylistic detailing, typically applied to the porches and gable ends.

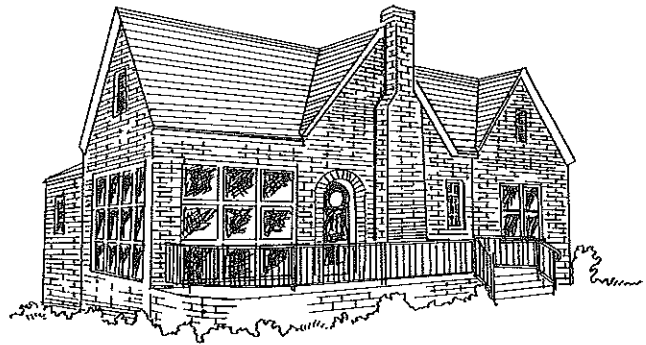
The Hines-Galloway House, East Main Street.

ENGLISH VERNACULAR REVIVAL (1915-1940) - This style appeared in many of Georgia's developing neighborhoods and suburban areas in the early decades of the 20th century. As its name suggests, the style was derived from vernacular traditions in England. Characteristic features include steeply-pitched roofs, asymmetrical front facades, casement windows and brick masonry as an exterior surface material.

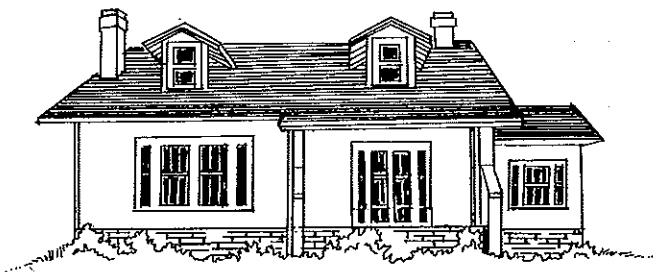
209 Johnson Street.

CRAFTSMAN (1905-1930) - Very popular during the first decades of the 20th century, the Craftsman style is quite different from other styles of its era, for instead of harkening back to earlier times it truly broke new ground. Craftsman houses emphasize structure and materials, and dwellings influenced by this style are found in every community in the state.

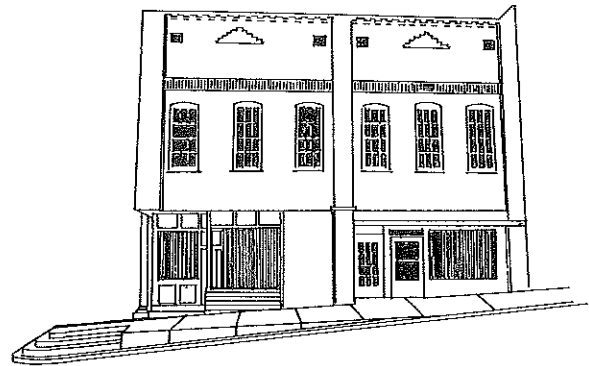
Thrift Store - Askew Building, East Main Street.

Two-part Commercial Building — The two-part commercial building developed in the mid-1800s and is by far the most common compositional facade type in the United States. Historically, the ground level of this type housed "public" commercial spaces such as shops or restaurants while upper levels housed "private" uses such as apartments, hotel rooms or offices.

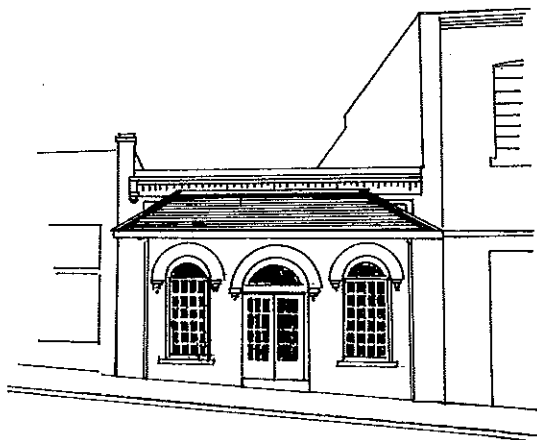
Hogansville Cleaners, East Main Street.

One-part Commercial Building — Also quite common throughout the country is the one-part commercial building, which, like the two-part building, became popular in the mid-1800s. This one-story type may be thought of in the same way as the street-level floor of the two part commercial type. It is a rather simple box featuring a front facade ranging from the very plain to the moderately ornamented.

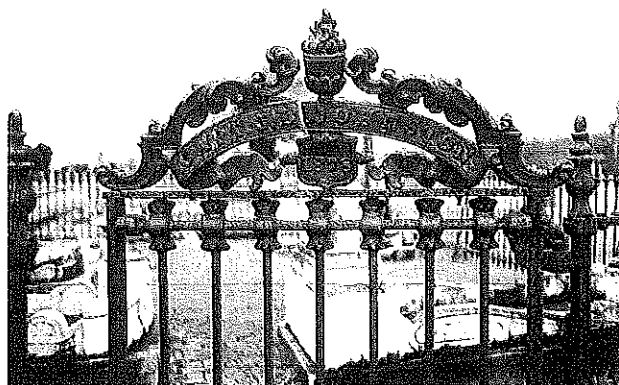
Iron fence, Myrtle Hill Cemetery.

Fences, while not very common in Hogansville today, were popular during the late-19th and early-20th centuries in most Georgia communities, so it is likely that they were common here as well. The prominent material was cast-iron, but little of this material is to be found in Hogansville today, reflecting the decline of enclosures that occurred as the 20th century progressed. Present-day enclosures range from wood picket and chain-link fences to vegetative hedges, with the only iron fencing being in Myrtle Hill Cemetery. Relatively few of the existing enclosures are considered historically significant to the community because most date from the past 50 years, but some are certainly appropriate and add character to the town's residential areas.

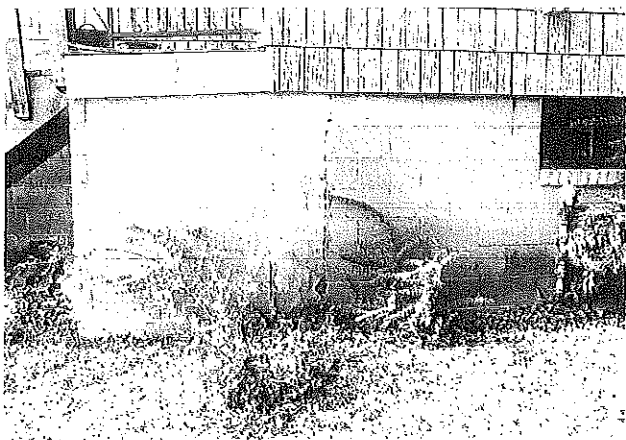
The original brick pier foundation of this house has been infilled with concrete block and the piers have been faced with stucco. The result is that the appearance of the original open foundation has been completely lost.

appropriate, is brick infill with a lattice-type (i.e., not solid) pattern. Again, it is important that the infill material be slightly recessed to accentuate the piers. All foundations must have some means of ventilation so that moisture will not accumulate in these spaces and lead to deterioration.

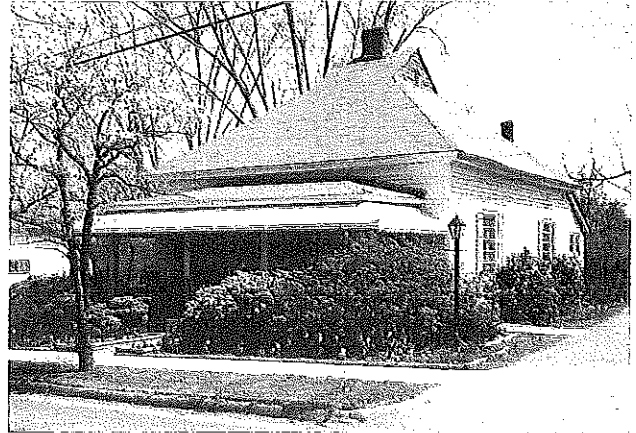
The gable-on-hip roof may be seen on several Granite Street houses in Hogansville. It is a very distinctive roof type and is an example of how important roof form can be in defining the character of a house.

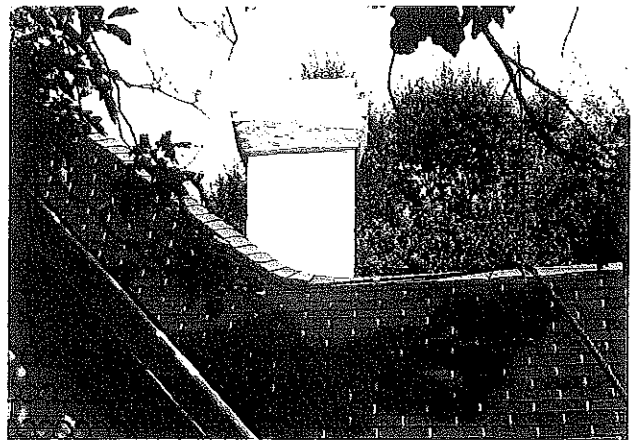
This historic brick chimney has been improperly maintained, as the stucco facing greatly detracts from the historic integrity of both the chimney and the house.

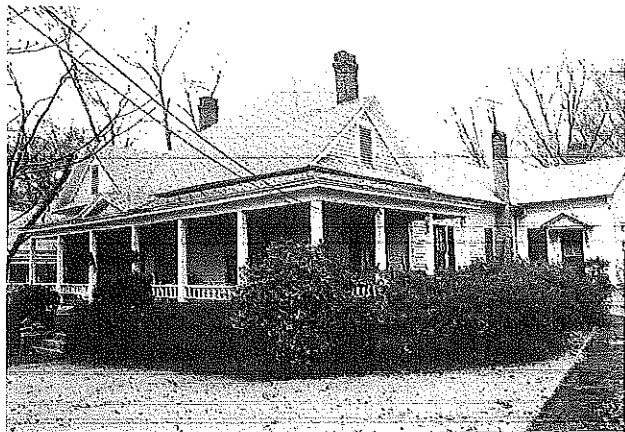
This house exhibits four properly-maintained brick chimneys that contribute to the building's architectural character.

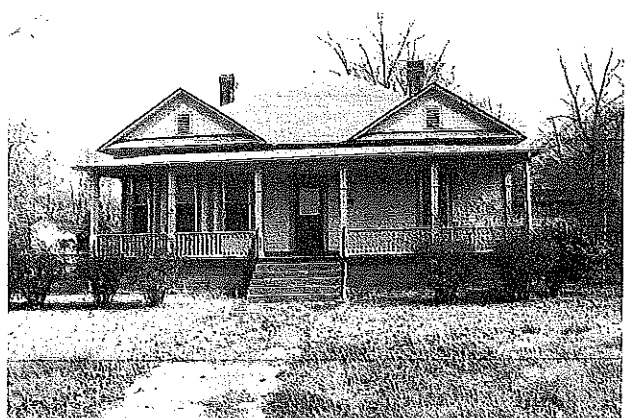
The gutters and downspouts on this house are barely noticeable; they are well-positioned and unobtrusive.

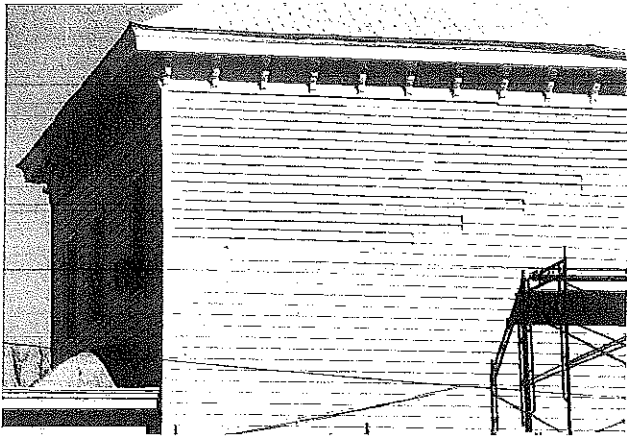
This historic house is undergoing application of vinyl siding. Even when the new treatment is visually acceptable, the risks of damage resulting from trapped moisture remain significant.

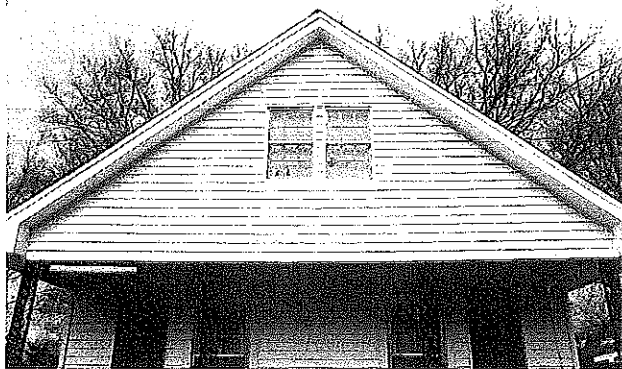
*The windows of this house reveal a poor job of applying vinyl siding. The window surrounds have been covered over, greatly altering the appearance of the house. The use of artificial sidings **must** be accomplished without the loss of architectural detailing.*

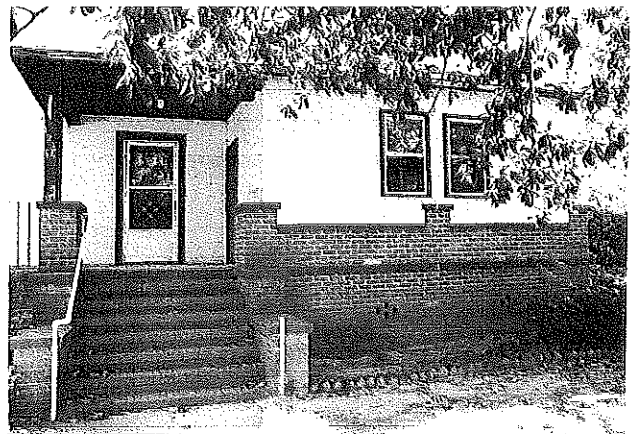
Two of this porch's three bays have been inappropriately infilled. The remaining brick piers indicate the former location of porch supports.

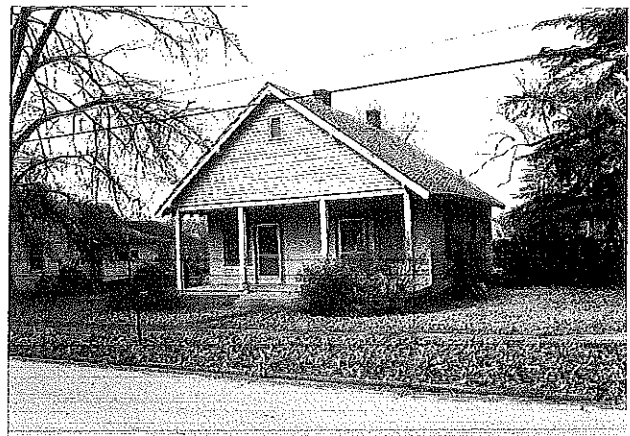
The integral or recessed porch is vital to the architectural integrity of the house type known as the Temple-front Cottage. The porch of this particular house has been well-maintained.

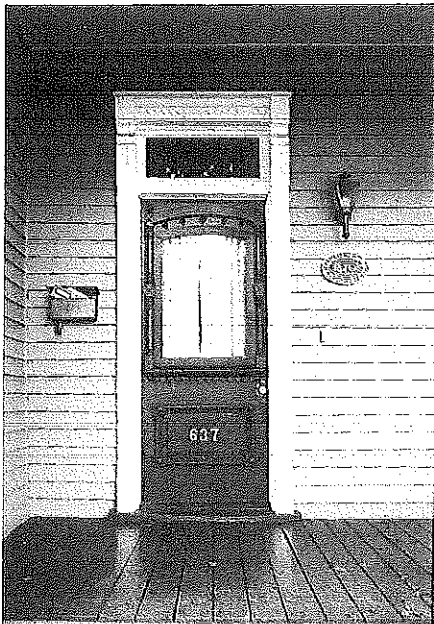
A well-maintained entrance is obviously important to the overall integrity of a historic house.

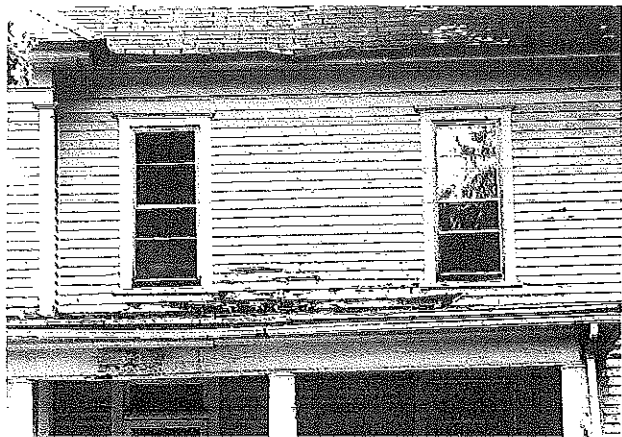
These replacement metal windows are inappropriate. A two-over-two pattern with horizontal muntins is not historically authentic, and neither is the metal material.

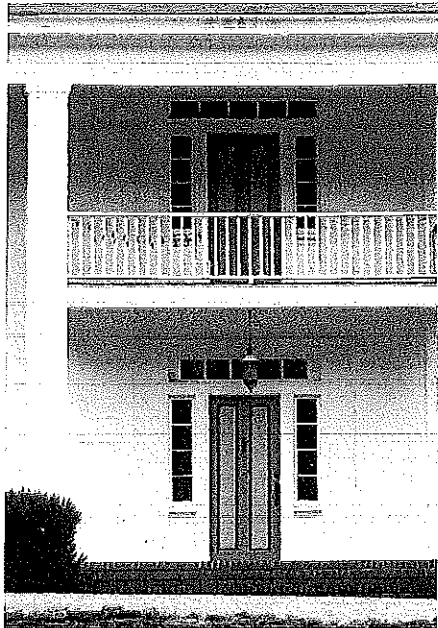
The transoms and sidelights of the Phillips-Smith House in Hogansville are important architectural details, helping to define the character of this particular house.

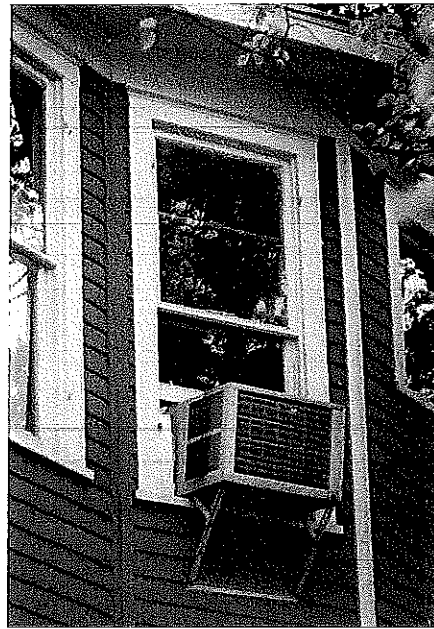
Window air conditioning units should never be positioned on the front facade of a house, but rather to the rear or at a view-obstructed location.

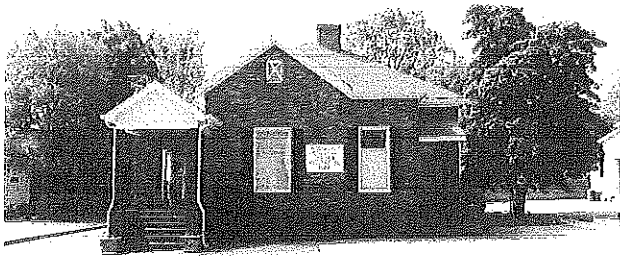
The conversion of this house to commercial use has resulted in several inappropriate alterations. Original weatherboard siding has been replaced with brick, the entire front, side and rear yards have been paved for parking purposes, and a business sign has been placed directly on the building's front facade.

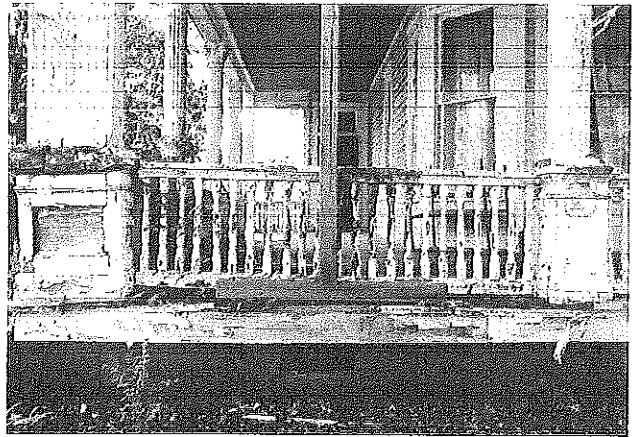
This porch balustrade is seriously deteriorating from lack of maintenance. Most of the damage appears to be moisture related. Some materials might be salvageable, but others may be beyond hope.

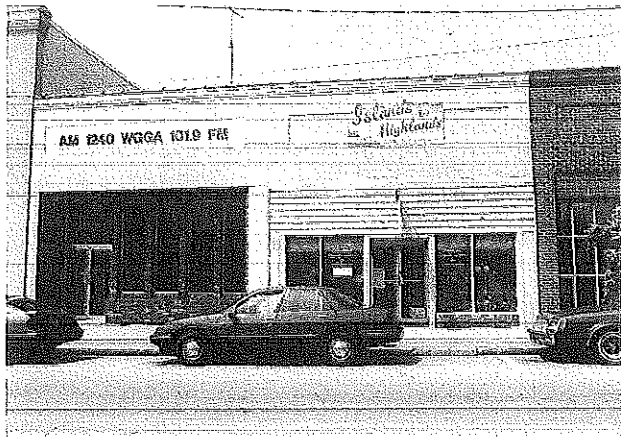
The two storefronts of this building have been severely altered, so much so that it is impossible to determine how the original storefronts might have appeared.

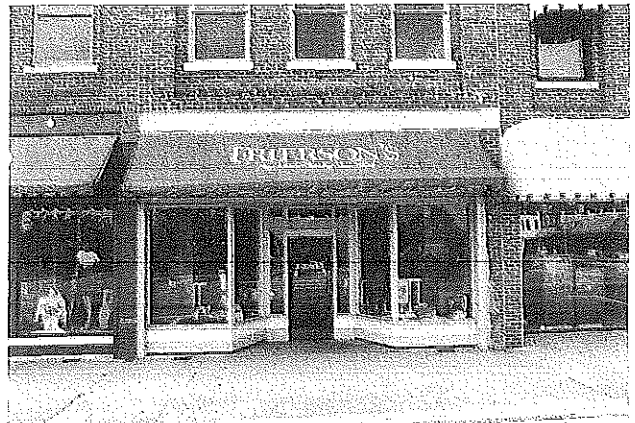
Looking much as it probably did originally, this storefront serves as an excellent example of sound commercial building preservation.

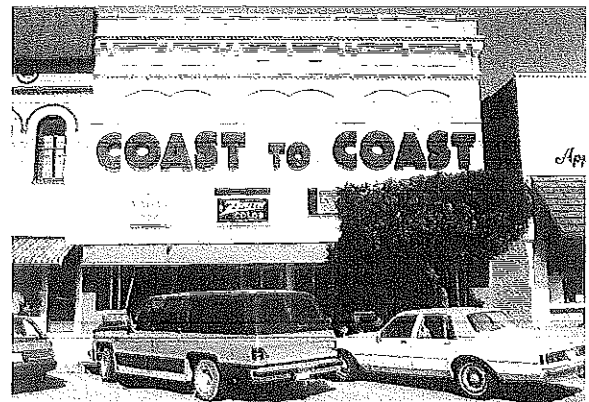
The second floor openings of this building have been inappropriately infilled with brick and an over-sized sign has been applied over this area. What was once a fine building with interesting brick detailing has suffered an almost complete loss of historic integrity.

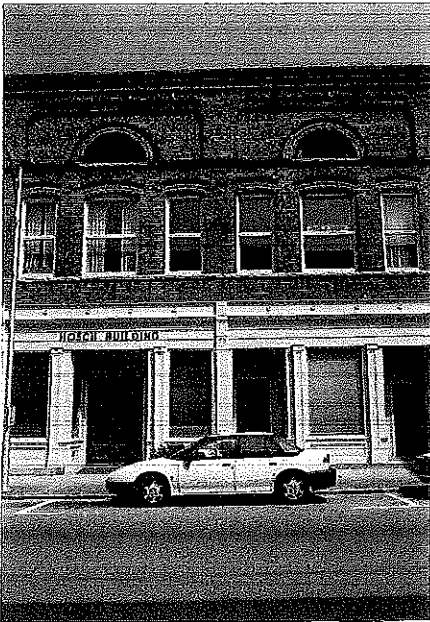
The upper level of this well-preserved building is in use as office space.

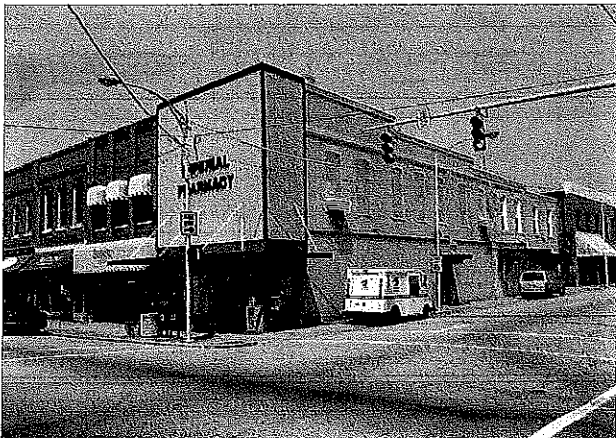
This brick building has received a variety of insensitive treatments. The original brick has been stuccoed over, metal siding has been applied to the front facade and second level openings have been boarded up. Obviously, this building detracts from the historic structures nearby.

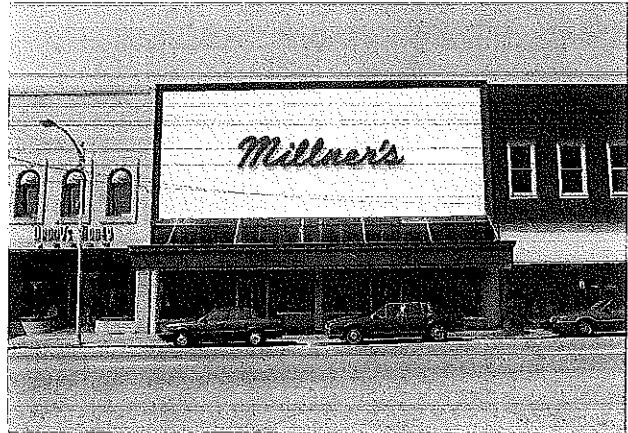
Whatever ornamentation this building once had has been completely obscured.

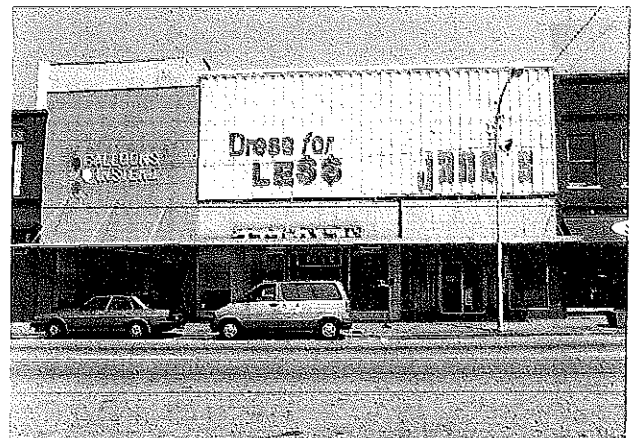
The signs on these buildings are completely inappropriate. Upper level window openings and detailing have been covered and the signs now totally dominate both buildings.

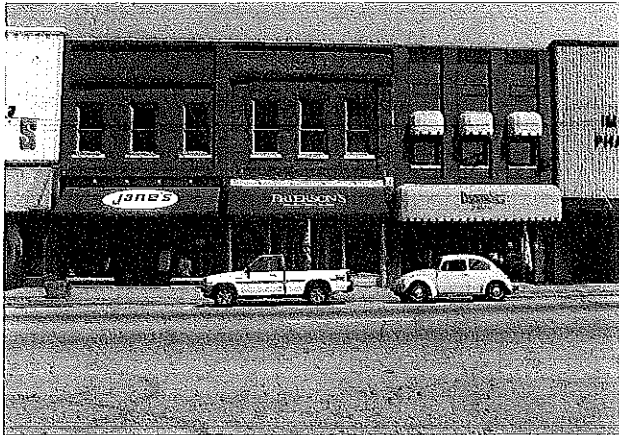
The canvas awnings at the center and left in this photograph are appropriate, while the awning on the building to the right is not historically accurate.

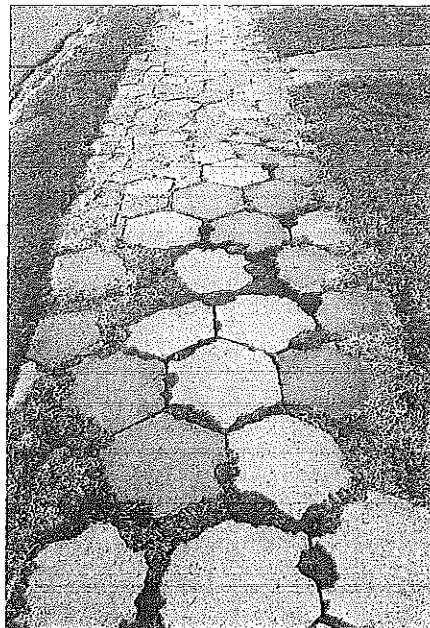
These hexagonal pavers are an example of historic public right-of-way elements that should be preserved. It may be necessary to repair this sidewalk by removing the pavers, leveling the ground and then simply reapplying the pavers.

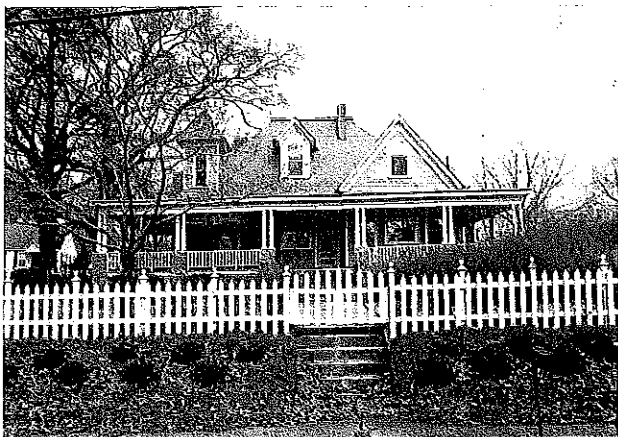
While not historic, this picket fence is appropriate for a Victorian-era house.

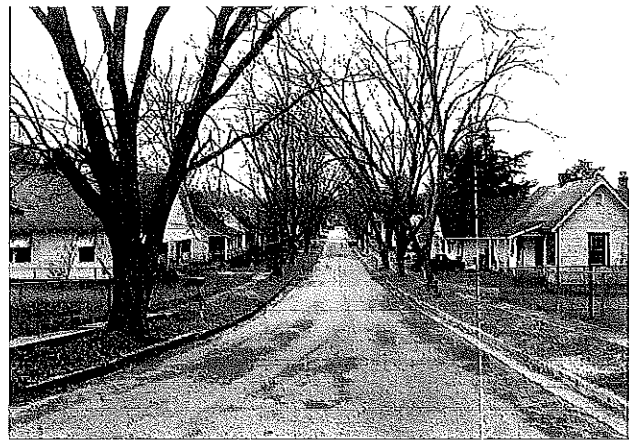
This view along Frederick Street shows the importance of mature street trees in defining the character of an area.

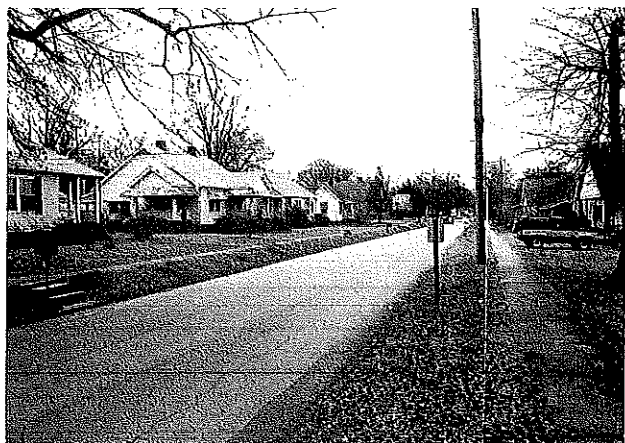
The loss of street trees is readily apparent in this view along Askew Street.

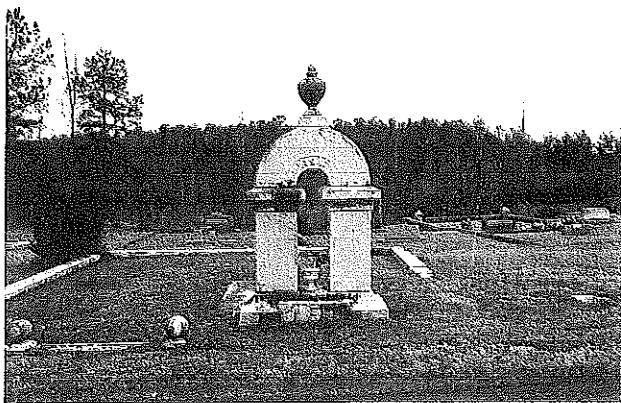
Historic cemetery monuments such as this example should only be cleaned using sensitive methods.

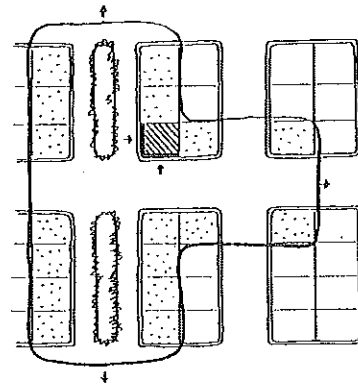
Shown here is a hypothetical area of influence for the highlighted corner site. A site in the middle of the block would probably require a somewhat smaller area of influence. This is because in such a location only the front facade of the subject building would influence buildings other than those to either side. Two facades are especially important to corner sites since these sites relate to two streets and will influence buildings in as many as four blocks.

Whenever an addition or new construction is being considered, an *area of influence* should be established for the subject property. Included in the area of influence will be those nearby properties likely to be affected by the project. Each site in Hogansville will have its own unique area of influence. New construction should not have a negative impact on other properties within the area of influence in any of the design areas that follow.

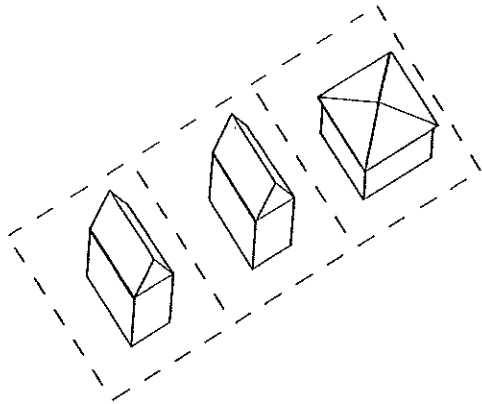
This example shows two houses with front-to-back orientations and a neutrally oriented new building that is inconsistent with the established orientation pattern due to its square plan shape. In addition, this building is considerably wider than the other two.

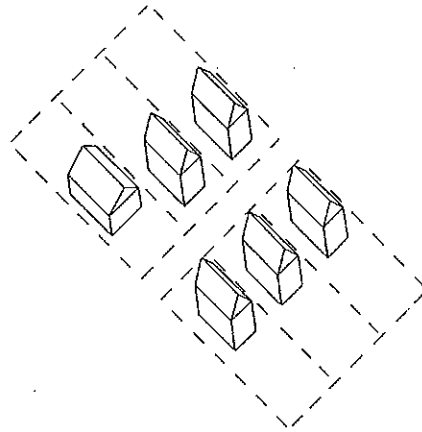
This example shows a new building in violation of the established set-back pattern along this street. The new building is properly oriented front-to-back on its site, however.

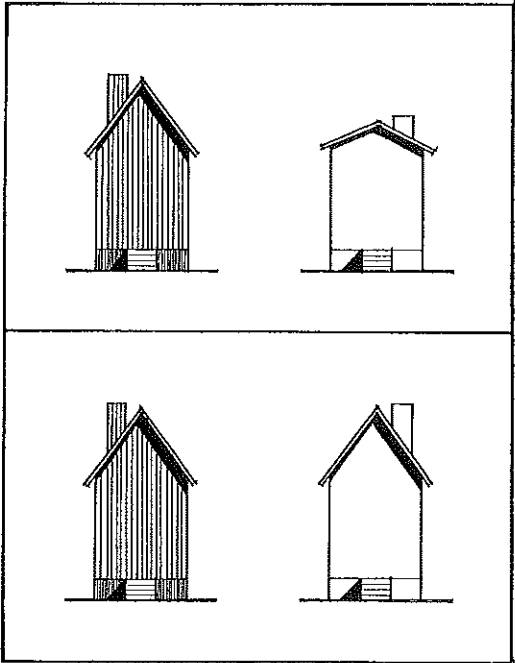
These two comparisons depict relationships between historic and new buildings in terms of roof pitch. The upper example is that of a historic house (shaded) with a steeply-pitched roof standing next to a new building with a shallow-pitched roof. The lower example shows a more compatible roof pitch on the new building.

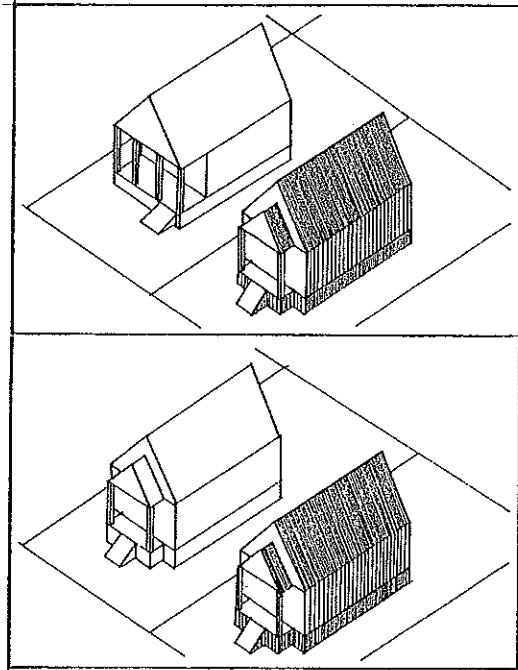
These two comparisons depict relationships between historic and new buildings in terms of porch form. The upper example is that of a historic house (shaded) with an extending front gable porch standing next to a new building with an integral porch. The lower example shows a more compatible porch form on the new building.

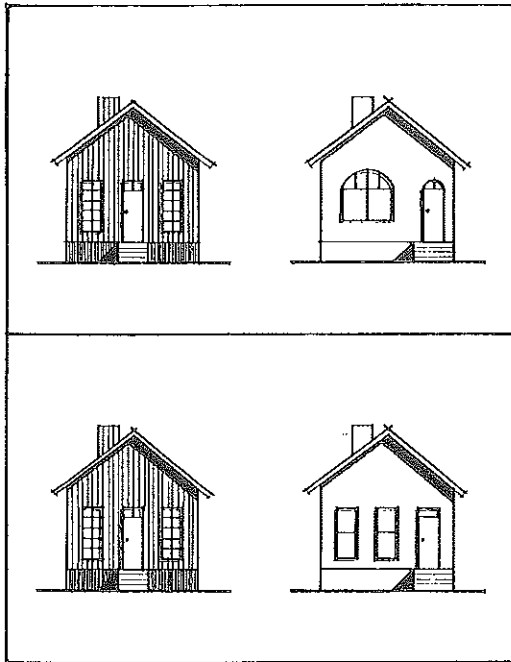
These two comparisons depict relationships between historic and new buildings in terms of building elements. The upper example is that of a historic house (shaded) with flat-arched window and door openings next to a new building with round-arched openings. The lower example shows more compatible window and door openings on the new building.

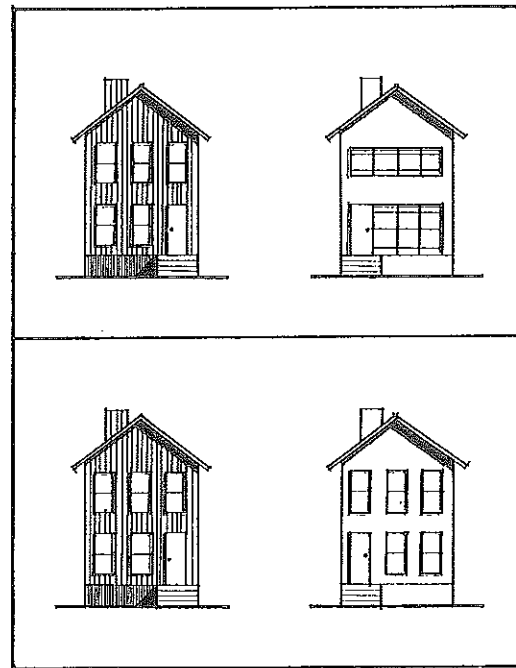
These two comparisons depict relationships between historic and new buildings in terms of the relationship of solids to voids. The upper example is that of a historic house (shaded) with evenly-spaced vertical sash windows standing next to a new building with large bands of glass resulting in a horizontal feeling even though the building itself is vertically oriented. The lower example shows a more compatible relationship of solid wall space to window and door openings on the new building.

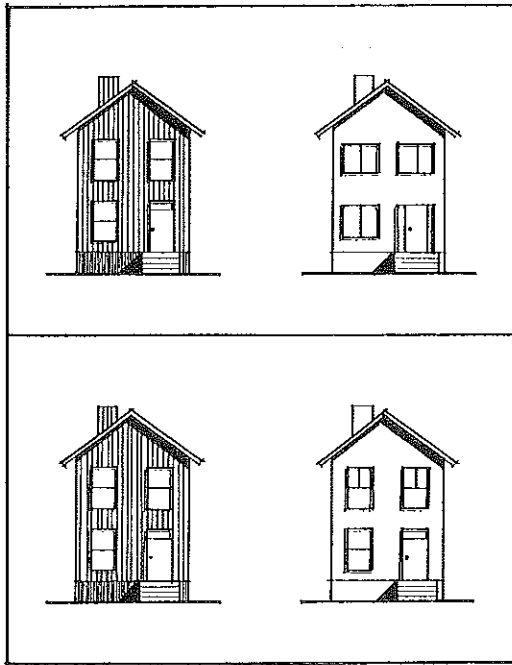
These two comparisons depict relationships between historic and new buildings in terms of opening proportions. The upper example is that of a historic house (shaded) with ordinary, vertically-oriented sash windows and a door with a transom over it standing next to a new building with horizontally-oriented windows and sidelights flanking the door. The lower example shows more compatible opening proportions on the new building, with the height and width of these openings in keeping with those of the historic building.

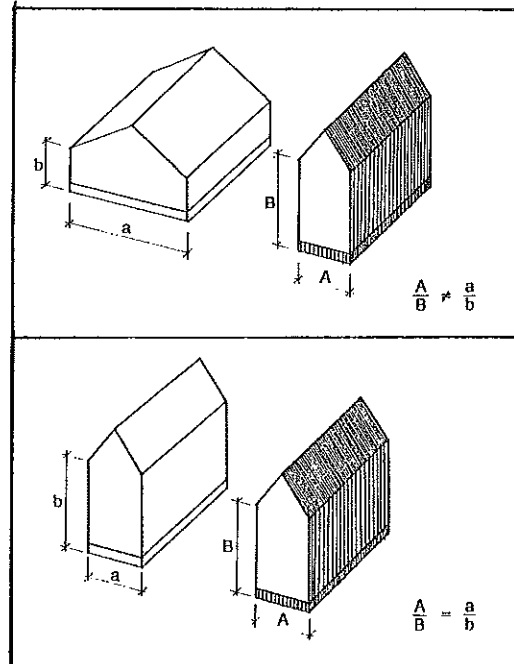
These two comparisons depict relationships between historic and new buildings in terms of front facade height-to-width ratio. The upper example is that of a historic house (shaded) with a height-to-width ratio resulting in a very vertical expression standing next to a new building with a horizontal height-to-width ratio. The lower example shows a more compatible height-to-width ratio on the new building.

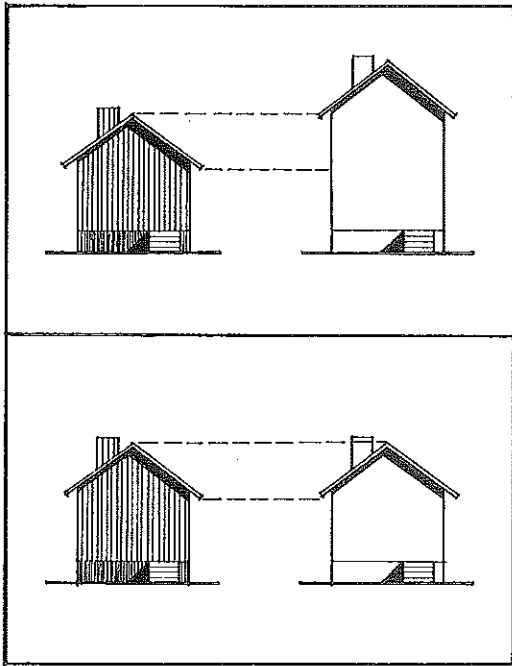
These two comparisons depict relationships between historic and new buildings in terms of cornice or eave height. The upper example is that of a historic house (shaded) exhibiting a much lower eave height than that of the new building. The lower example shows a more compatible eave height on the new building.

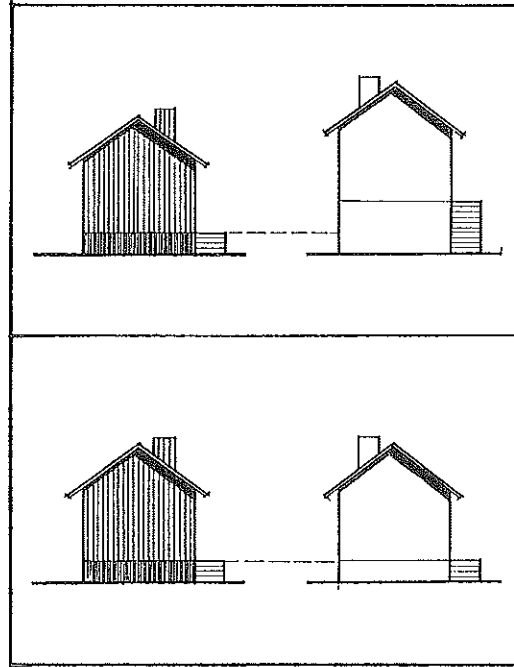
These two comparisons depict relationships between historic and new buildings in terms of first floor height. The upper example is that of a historic house (shaded) with a slightly raised first floor level standing next to a new building with a much higher first floor level. The lower example shows a more compatible first floor height on the new building.

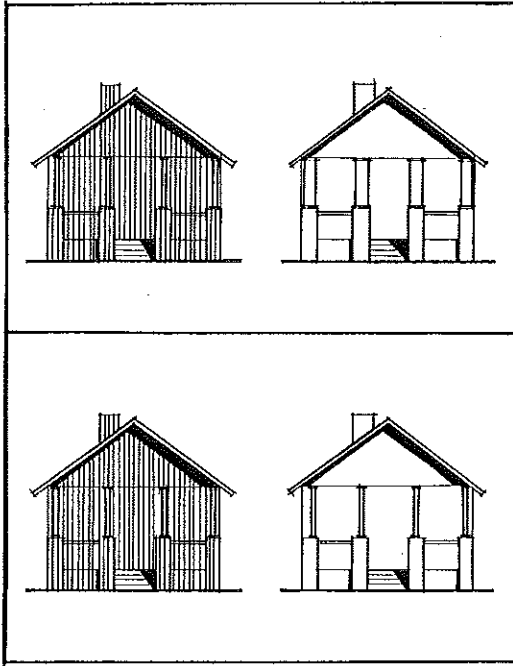
These two comparisons depict relationships between historic and new buildings in terms of element size. The upper example is that of a historic house (shaded) with slender porch supports standing next to a new building with fat, heavy porch supports. The lower example shows more compatible porch supports on the new building.

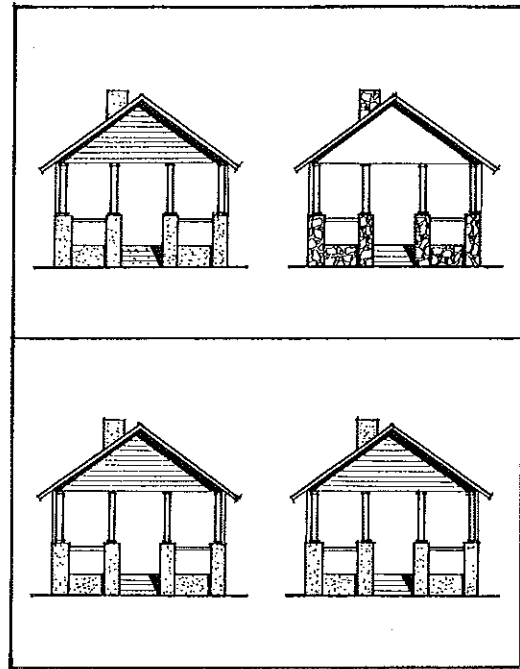
These two comparisons depict relationships between historic and new buildings in terms of exterior materials. The upper example is that of a historic house (on the left) exhibiting weatherboard in the gable end and brick porch piers standing next to a new building with a smooth material in the gable end and stone porch piers. The lower example shows more compatibility between the two buildings.
