City of Hogansville  
**City Council**  
Work Session Meeting Agenda  
**Monday, April 15, 2024 – 6:00 pm**

**Re: Building Exterior Consulting Services  
Leakage Evaluation Report  
Royal Theatre  
400 East Main St  
Hogansville, GA 30230  
(W&A- 24-00191)**

**Leakage Evaluation Report  
Royal Theatre  
400 East Main St  
Hogansville, GA 30230  
(W&A- 24-00191)**

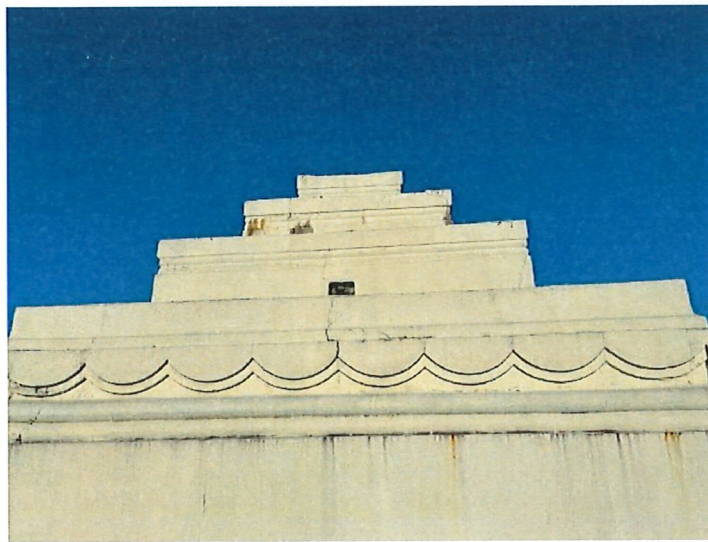
23

We were provided access to the top hat by Hogansville City Maintenance Department, accessed via a boom truck. **Photos 23–42** show the various conditions observed. **Attachment "B"** notes the various cladding elements.

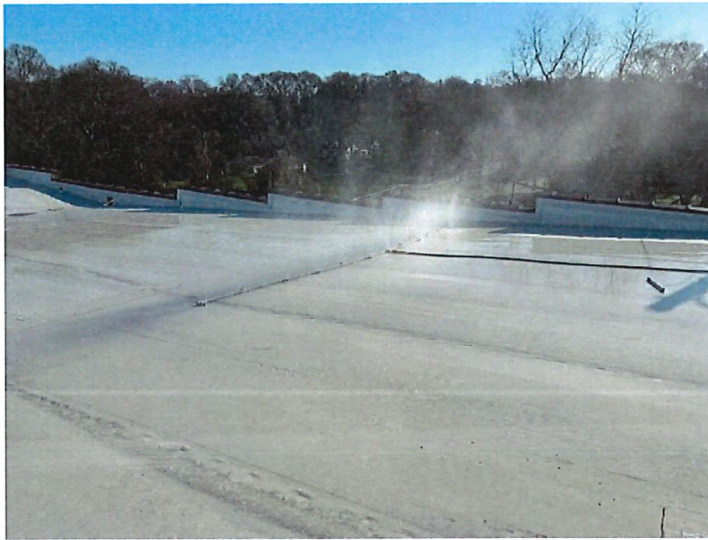
50

**Photo 50** shows the spray bar placed on the roof upslope of the valley, spraying water into the air then cascading back onto the roof. **Photo 51** shows the sheet flow of water on the roof surface, directed from the valley/crickets to the east scupper. During the test, water was observed leaking from joints in the conductor head and downspout (**Photos 52-54**). During the 2-hour test, no leakage was witnessed below the roof on the interior.

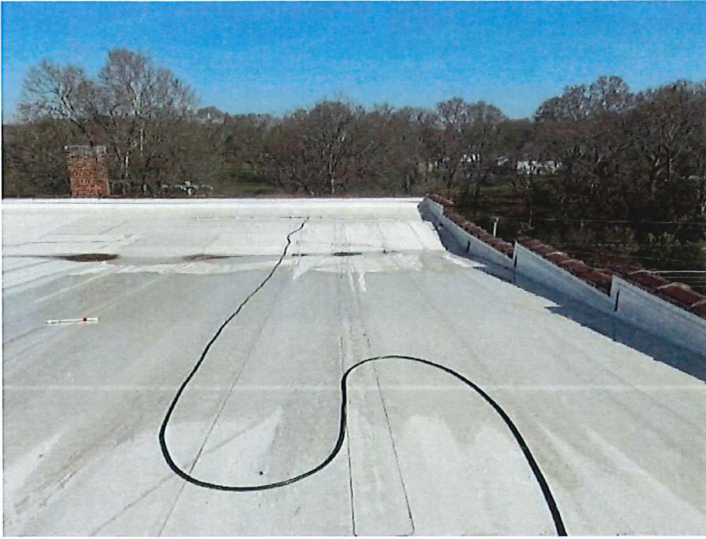
55

**Photo 55** shows the spray bar placed on the roof upslope of the valley, at the north end of the roof. Water was sprayed into the air then cascading back onto the roof. After approximately 1 hour testing, water was seen leaking below the steel truss and running down the wall behind the duct work (**Photos 56-58**). The test was stopped. The leak is suspected to water penetrating the scupper sleeve penetrating the masonry parapet and or from saturation of the mass masonry wall below the scupper being wetted by the leaking conductor head.

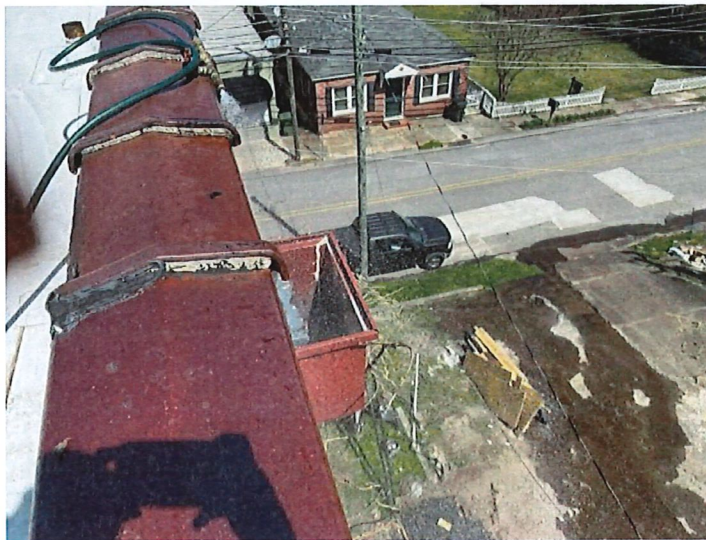
59

After observing the leak. We placed the handheld nozzle atop the terra cotta coping with water spray directed at the conductor head and mass wall (**Photos 59-60**). **Photos 61-62** shows voids in the mortar joints that will permit water penetration of the wall. During this test, there was a significant increase of water penetrating the mass masonry wall (**Photos 63-66**).

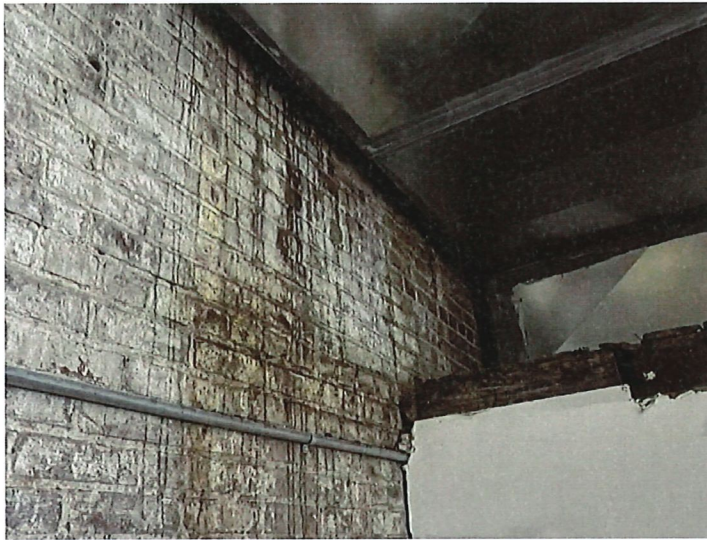
63

Leaks associated with the mass masonry wall appear to be contributed to voids in the existing exposed mass masonry wall construction, penetrating voids in mortar, cracks in mortar, and through cracks in the brick. The application of a water repellent likely will not prevent leakage. Masonry repairs are recommended to improve visual watertightness of the mass masonry wall, we recommend the following:

- Access the building exterior to inspect the existing masonry. Locate deteriorated mortar and cracked mortar. These areas should be abraded to remove mortar to a nominal depth of 1-1/4" to repoint the walls using a water repellent admixture like Grace Dryblock to the mortar mix. With

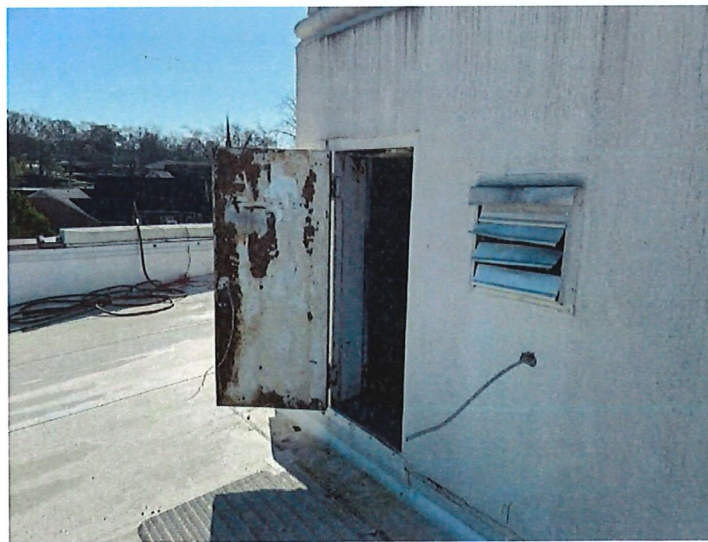
83

The roof is accessed through a small sized steel hollow metal door/frame. The frame is significantly corroded and will permit water penetration through/around the door and cause leakage in the projector room (**Photos 83-85**). The door should be replaced with a new access door that has watertight performance ratings to reduce the risk of leakage.

W&A also recommends replacing the roof access door, as the door is significantly corroded at its' head and sill, and the door does not properly close. Rainwater will penetrate the access door, as it is not weather protected.
